SHELTON ABBEY

Background information

Mine Name: Shelton Abbey

Alternative Names:
Avoca Tailings Pond

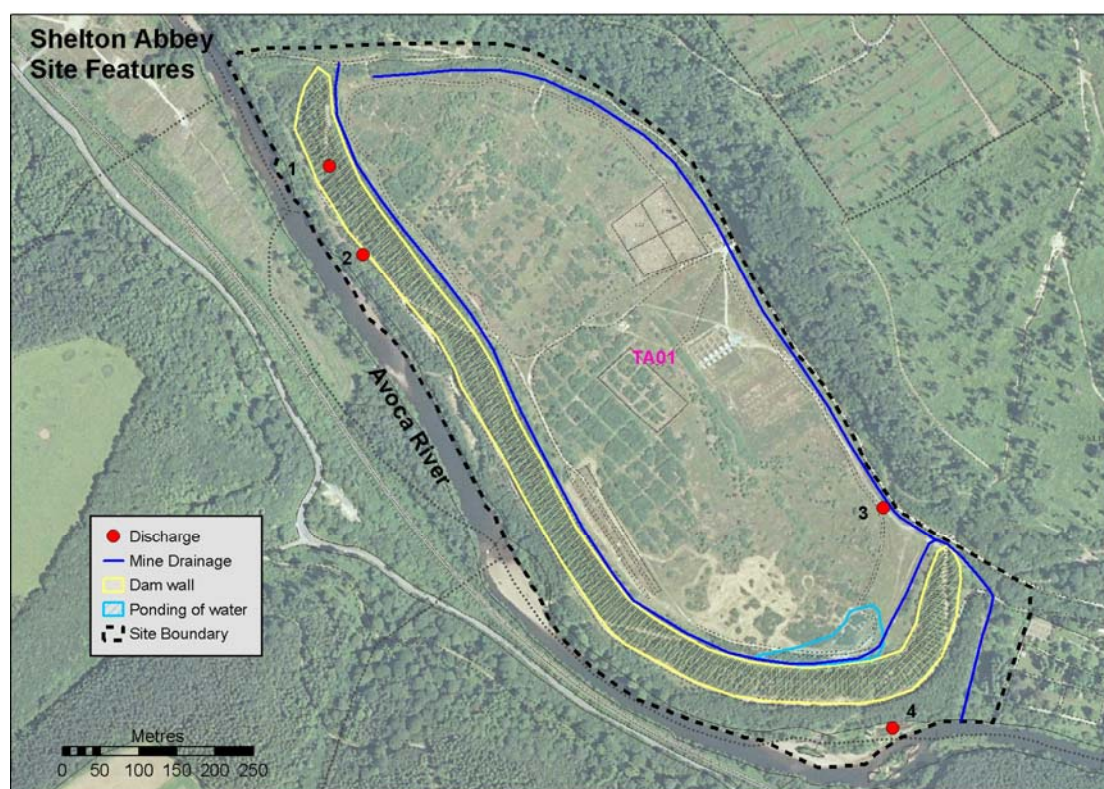
Fig. 1 Shelton Abbey: site features

The site is bounded to the southwest by the Avoca River (Fig. 1). The northeast boundary is a cliff, apparently created in the course of construction of the tailings pond, and its top is covered by a forestry plantation that extends around to the northwestern end of the tailings pond. To the southeast is Shelton Abbey, now in use as an open prison, and beyond it the former fertilizer plant, now the site of a business park.

Although the rehabilitation of the tailings pond has been broadly successful, a number of issues were identified in the course of the HMS-IRC project and the Avoca Feasibility Study. Seepages occur at several points along the toe of the inner dam wall (Fig. 1) while pH measurements in the Avoca River suggest that seepages are probably discharging from the lower, original dam along the riverside. A small backwater to the Avoca River (site 4 on Fig. 1) was found to have low pH and high metal concentrations, indicating input from seepage. Surface drainage on the tailings pond is via ditches running around the perimeter. Both lead to a drain at the eastern end of the site. This drain runs into a pipe on the flat ground east of the dam wall and thence to the river. The drains are ineffective and tend to draw water onto the tailings rather than drain it off. Extensive ponding of water has taken place at the southeastern end of the tailings pond (Fig. 1). This appears to be the result of blocking of the culvert at the northeastern end of the site where the water should flow into the northwest-southeast-trending ditch and thence to the pipe.

GWP concluded (CDM 2008) that despite the deficiencies in dam construction techniques, the Shelton Abbey tailings pond exhibited no signs of current instability. The main risk to stability could come from dam erosion by floodwaters of the Avoca River. Drilling on the pond as part of the HMS-IRC geochemical programme indicates that only the top 1m or so of tailings is dry – below this the tailings consist of a grey plastic mud that becomes progressively less viscous with depth. Failure of the dam wall would, therefore, have potentially serious consequences.

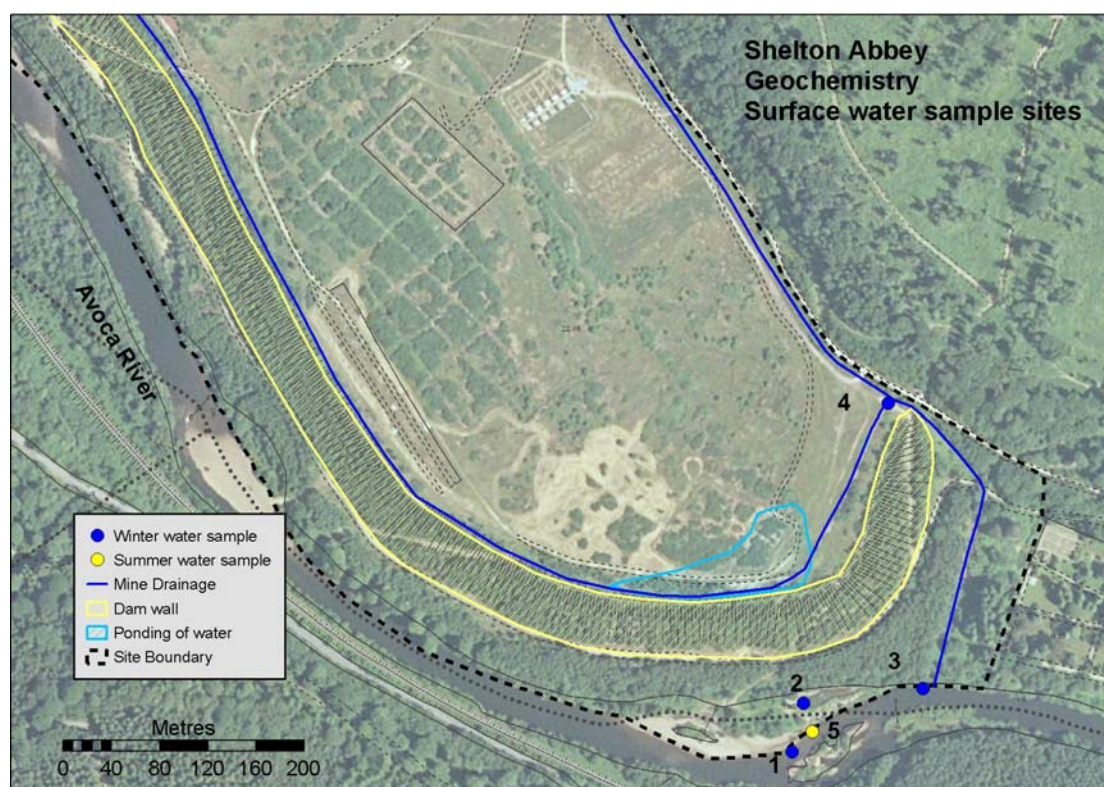
Fig. 2 Location of surface water sampling sites, Shelton Abbey

Several surface water samples were taken from the Avoca River at the southeastern end of the tailings pond, mostly in November 2006, with one additional sample in June 2007. The small backwater apparently affected by seepage from the tailings pond was also sampled as was the water draining from the surface of the pond. Results are summarized in Table 2 where they are compared to the Avonmore River sample also taken in November 2006.

The backwater sample is clearly affected by seepage from the tailings pond – low pH, high acidity, high Zn and Cu are all consistent with such an event. The surface drainage sample shows reduced pH compared to normal river water or rainwater and may reflect interaction with the exposed tailings. However, none of the metal concentrations suggest that this interaction, if it is occurring, is happening to a particularly significant extent. The river water samples do not suggest significant contamination from any mine-related source. One has a measured Pb concentration 35 µg/l Pb, another 284 µg/l Zn. Both these results are suggestive of some input from mine drainage, i.e. tailings seepage.

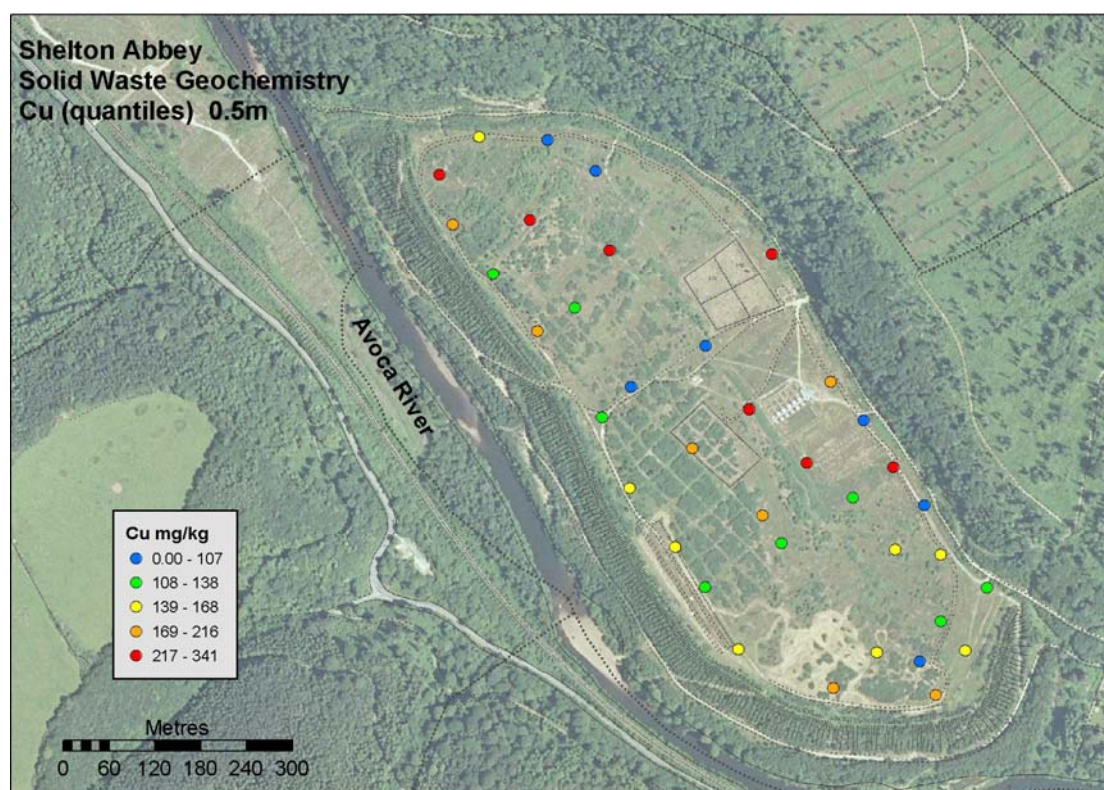
Fig. 3 Distribution of Cu in tailings, Shelton Abbey: 0.5 m depth

The tailings pond was sampled using a trailer-mounted auger drill. The grass and soil cover was stripped back at 37 sites before drilling and samples were retrieved from nominal depths within the tailings material itself of 0.5m, 3.0m and 5.5m. Below c. 1.0m the tailings change from grey-green sandy material to a grey, plastic mud that becomes less viscous with depth. Table 3 summarizes the data for elements of interest; median values are given for each of the three different depths sampled. Fig. 3 – 5 shows the distribution of Cu in the tailings pond for each of the three different depths.

Table 3 suggests that Pb, Cu and Zn concentrations in tailings increase below a depth of 1m in the tailings pond. However, as the comparison with Avoca spoil medians shows (Table 3), absolute concentrations of these metals within the tailings are relatively low in the context of the Avoca site as a whole.

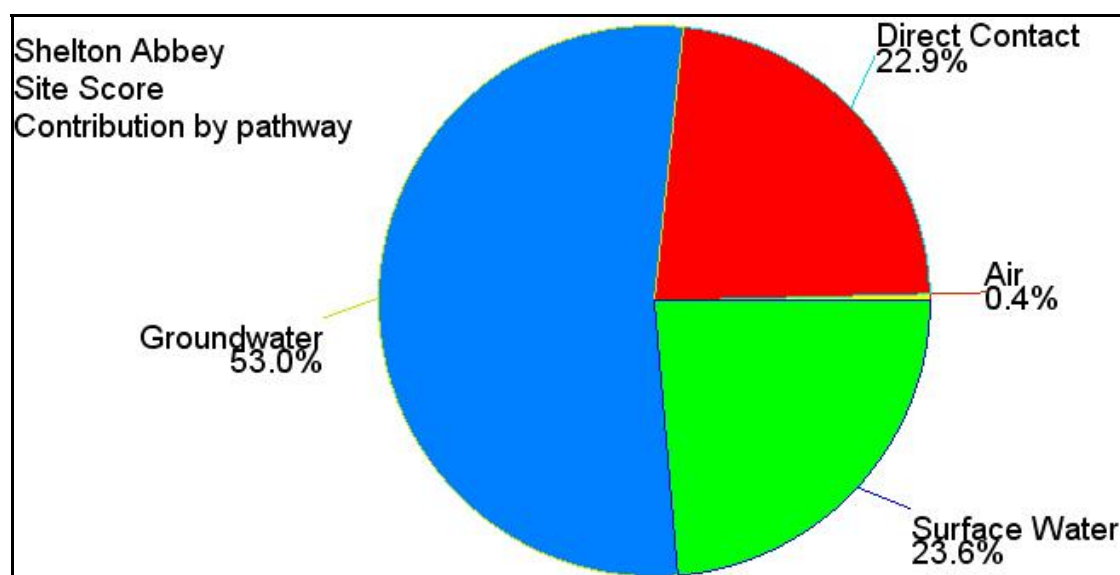
Fig. 6 Shelton Abbey Sites Score: contribution by pathway

The total site score for Shelton Abbey is 64 (Table 4). The total score for the Avoca District as a whole is 2438, of which the solid waste score is 979. Thus the tailings pond at Shelton Abbey, although it makes up 85% of the total volume of solid waste at Avoca, contributes only 6.5% of the score that is attributable to solid waste. This is simply a consequence of the much higher concentrations of metals found in spoil heaps at East and West Avoca. For example, Mount Platt (SP20) in Cronebane, with c. 11% of the volume of the tailings pond, contributes a score of 368.

Water in the Avoca River shows no apparent impact from the tailings pond whereas a leachate test confirms the potential for groundwater contamination, something that agrees with the composition of water in a monitoring well at the tailings pond. This, together with the large volume of the waste, gives the groundwater pathway has a much higher score than other pathways (Fig. 6). The large volume of waste and the proximity of the site to the river ensure the surface water pathway score is also substantial. The large surface area of the tailings pond and the use of the site by a gun club, both for breeding pheasants and shooting, which emphasizes the attractiveness of the site for recreation, have resulted in a relatively high direct contact pathway score. Revegetation of the surface of the pond means that the potential for dust blow is minimal, resulting in a very low air pathway score (Fig. 6).
