CAMINCHES STAMPS

Background information

Mine Name: Caminches Stamps

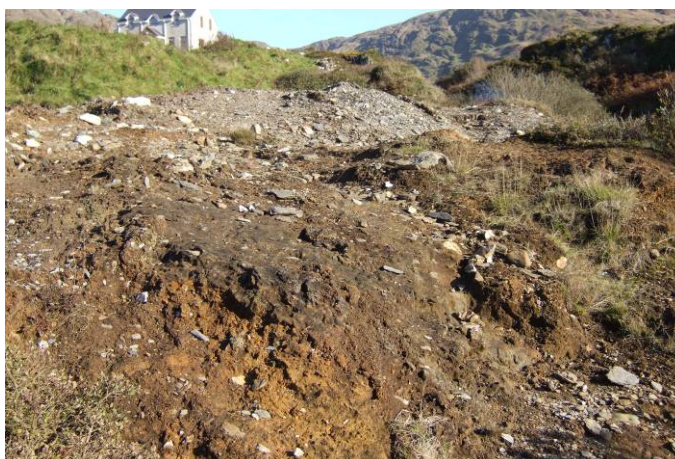
Two waste heaps are the main evidence for former mine-related activities on the site. Both have Fe-oxide-rich horizons that are typical of stamps waste. The waste heap on the east side of the public road, SP08, is on unfenced scrub land (right); SP09 to the west is mostly contained within a fenced pasture field. An iron support, driven into the bedrock, is the only evidence for the central stamp battery (Fig. 1).

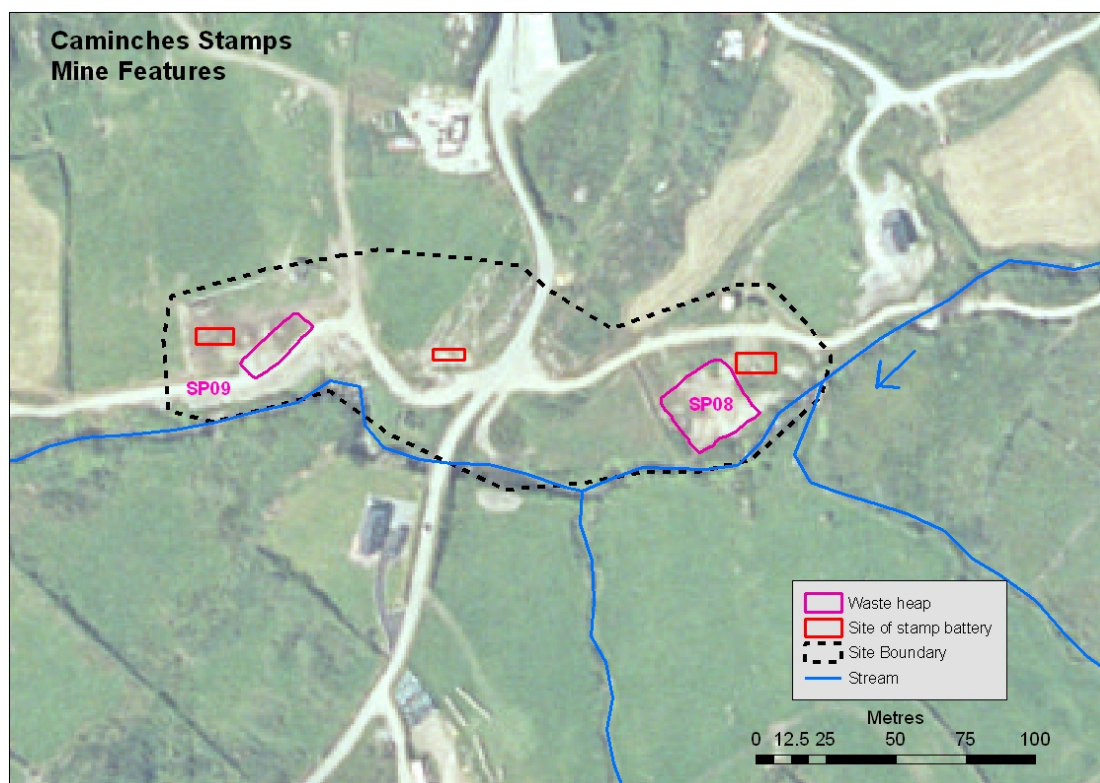
Fig. 1 Caminches Stamps: mine features

This site hosted stamp batteries for Caminches mine. No detailed information is available for the site. The locations of the stamp batteries are marked on the 1837 six-inch maps (Fig. 1) but not on subsequent ones. The site is on the banks of Ballydonegan River, several hundred metres south of the mine site, and was presumably chosen in order to exploit water power to run the stamps. As defined for this project, the site occupies 1.4 ha. Most of the surrounding land is used for cattle pasture. A small number of farmhouses in the area has been augmented by a growing number of newly built houses, including holiday homes.

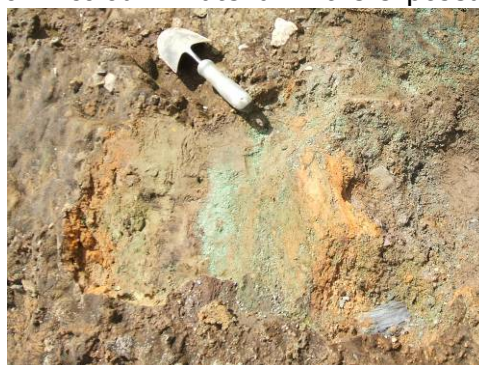
The solid waste at the eastern part of the Caminches Stamps site (SP08) is typically fine-grained, sandy material of brown to red-brown colour. Material in the exposed, 2m-high bank where SP08 borders the Ballydonegan river has blue-green horizons (right) apparently rich in Cu oxide. Analysis of these horizons in vertical profile reveals the highest Cu concentrations in solid waste found in the Allihies district. Measured Cu in the five vertical profile analyses ranges from 2289 to 75580 mg/kg, i.e. up to 7.5% Cu. Two of the other vertical profile analyses yielded values of 2.0 and 5.1 % Cu.

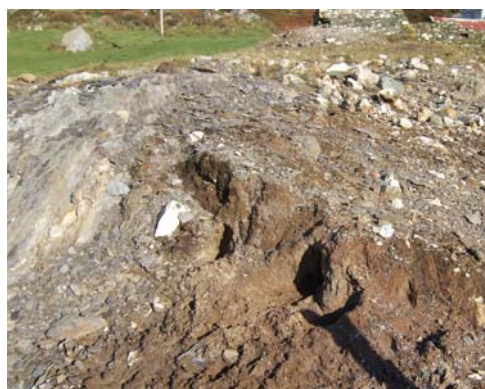
The waste heap on the western part of the site (SP09) is similar in texture and colour to that on the east but also contains an abundance of coarse clasts or cobbles on its surface (left). The waste heap is draped over an outcrop of siltstone and is relatively thin. It is within a pasture field and is commonly traversed by cattle. Of two analyses carried out, one measured over 2% Cu.

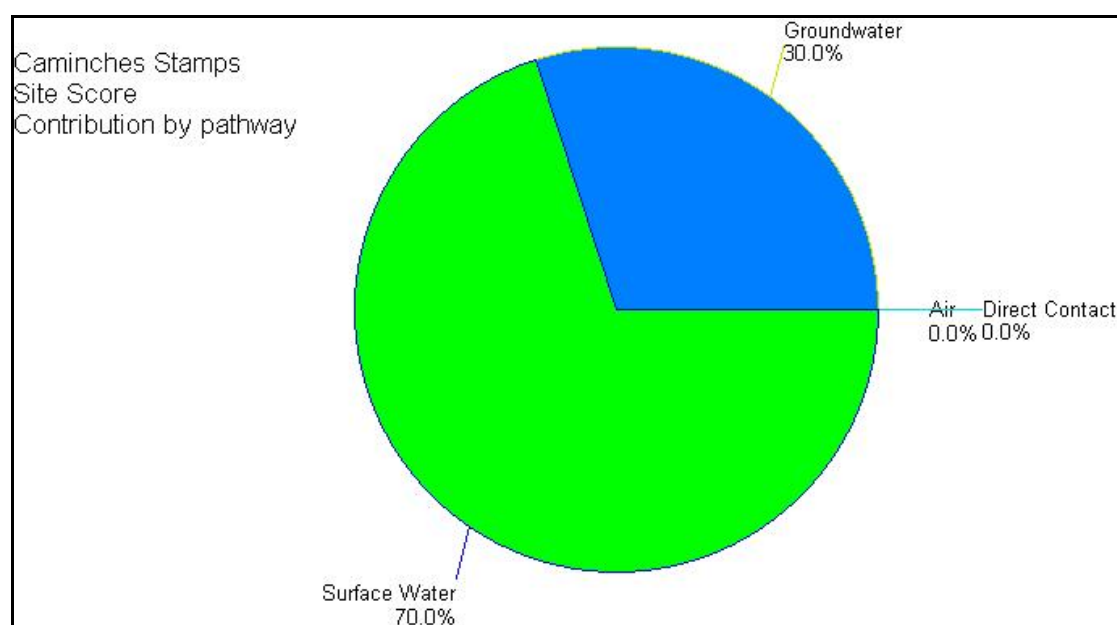
Fig. 3 Caminches Stamps HMS-IRC Site Score: contribution by pathway

As is the case for the Allihies District as a whole, the surface water pathway (70%) is significant contributor to the site score than the groundwater pathway (30%) (Fig. 3). The low volume of waste, the lack of important aquifers in the area and the low population density, and hence small number of possible wells, minimize the groundwater pathway contribution while the location of the waste directly beside the Ballydonegan River maximizes the surface water pathway contribution. The negligible contribution of the Direct Contact and Air pathways follows from the low volume and area of the solid waste as well as the absence of significant

The total HMS-IRC Site Score for Caminches Stamps site is 10, with similar contributions from the two solid waste heaps defined on the site (Table 3). The Cu concentration of stamps waste is generally higher than that of other solid waste in the Allihies District and the scores for each of the heaps on the Caminches Stamps site are higher than those for other waste heaps of comparable size in the district.
