# LADY'S WELL

**Mine Name:** Lady's Well

**Project Prefix:** LDW

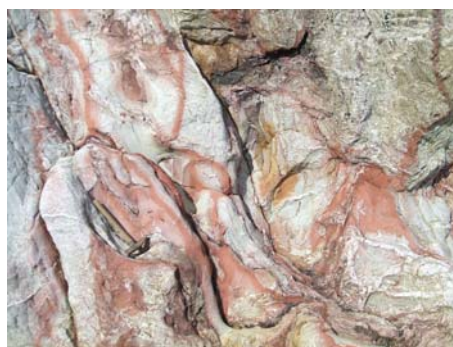
The Cu-Ba mines of West Cork are hosted by the Old Red Sandstone succession of the Munster Basin. The sediments of the Munster Basin were deposited in a half graben and subsequently uplifted and folded into eastnortheast-trending anticlines that now comprise the rugged peninsulas of the southwest corner of the island. The barite lode at Lady's Well is fault-hosted and cuts the strike of the host rocks at an angle of 15 to 45°. The vein is split into north and south branches and varies in width from 1 to 3m (Reilly 1986). The host rocks at Lady's Well are sandstones and minor siltstones of the Old Head Formation. According to Cole (1922) specks of Fe and Cu pyrites were present in the vein along with some galena. The sandstones are extensively bleached, veined and iron-stained up to 25m away from the main vein (photo, right) (Reilly 1986).

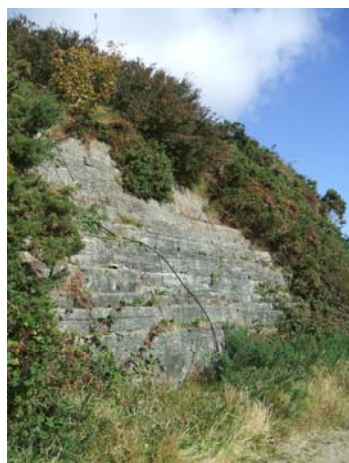
Most of the original features on the site have now been lost. The main open pit on the western side of the road forms the bulk of what remains of the site. Although the pit is largely backfilled, the original northern pit wall is still visible (photo, left). The quarry or open pit on the seaward side of the road is also backfilled. The area of the old ore stockpile became the site of serious subsidence in the mid 1980s and was backfilled with low-grade waste (Fig. 1). Some concrete buildings remain on site, apparently dating from the last period

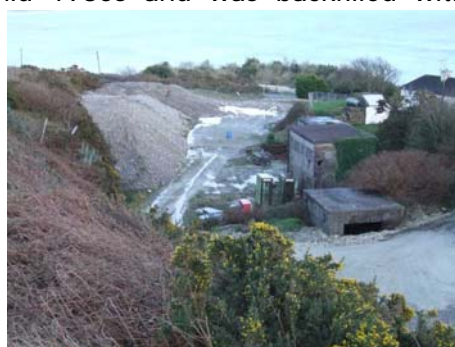
of mining in the 1980s (photo, below right). The site has been used in recent years as a dump for domestic and other waste.

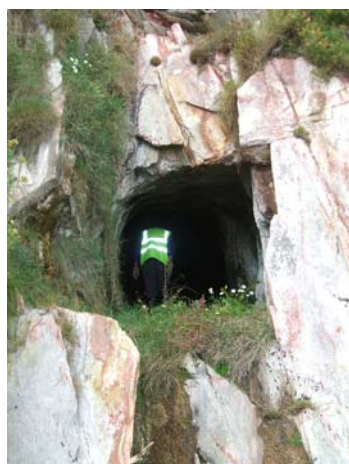
The main, eastern shaft has been capped with concrete. The western shaft is backfilled and not visible. The other shafts shown on Fig. 1 are in-filled and the ground landscaped. The adit at the western end of the site is backfilled although its outline is discernible. The entrance to the northern adit on the beach is covered by a collapsed fan of waste material. Iron-stained water discharges from beneath the waste, apparently a discharge from the collapsed adit. Its pH was measured as 6.76. Mine water at Lady's Well has been reported to be corrosive, i.e. of low pH, presumably as a consequence of pyrite in the vein material. The adit at the south end of the beach (photo, left) was driven on the South Lode and is intact – it can be entered for 20m or more.
