BUNMAHON DISTRICT

Background information

Mine Name: Tankardstown, Stage Cove, Knockmahon

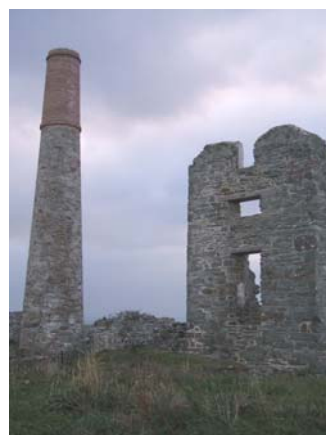
The Bunmahon mine district is located 15km west of Tramore on the Waterford coast. It comprises numerous individual sites among which Bunmahon, Tankardstown, Stage Cove and Knockmahon (Fig. 1) were the most important. All are located within a 5km-long stretch of coastline. The district has a significant physical mining heritage, principally in the form of the recently conserved Tankardstown engine house complex (photo, right). The district is the focal point for the Copper Coast European Geopark.

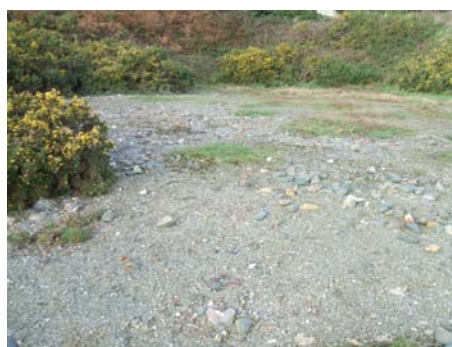
The Knockmahon site (Fig. 2) was the main processing area for the Bunmahon district during the MCI operations. Processing plant included an engine house, crusher, hoppers, stamps and buddles. Numerous mine buildings were also on site including the magazine and the extant remains of the MCI Directors' house, mine manager's house and count house (Tietzsch-Tyler 2005). The cobbled remains of the dressing floor can still be seen near the site of the former crusher (photo, right). The site of the dressing floor is partly overgrown by gorse and grass but there are large areas of unvegetated solid mine waste of various textures and colours that marks the site of the former stamps and buddles. A large fan of waste that silted up the river channel during mining (Tietzsch-Tyler 2005) has been reclaimed as a flat, grassy area in use as a pasture field.

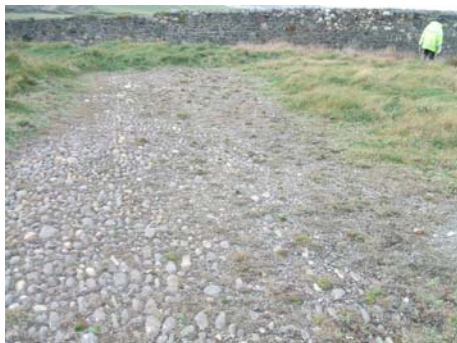
Stage Cove was a smaller site but still had a substantial engine-house complex (Tietzsch-Tyler 2005). Much of the site is grassed over. One ruined engine house remains on the landward side of the road while only a vague outline of the site of the remainder of the complex remains on the seaward side. Also on the seaward side of the road are the walled, cobbled processing yard and some shafts. There is an adit in the cliff-face below the yard.

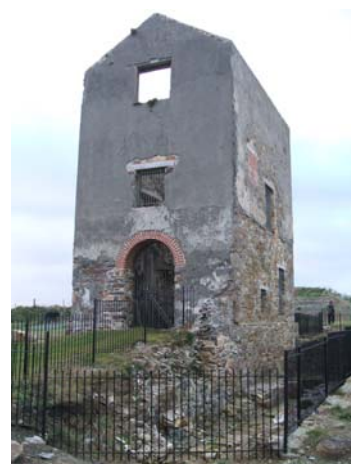
The Tankardstown site has been the subject of a major conservation project in recent years. The site has been cleared of overgrowth and the buildings made safe through structural repairs. Excavations revealed many of the features linking the buildings, allowing a fuller interpretation of the operation of the site. Fencing and signage have been installed. The site is now a major locus for the Copper Coast Geopark. The walled yard contains the partially restored pumping engine house (photo, right), the ruins of the winding engine house, a restored chimney and the foundations of the boiler houses (Tietzsch-Tyler 2005). The three shafts on the site are filled in. No mine waste was identified on the site and no geochemical assessment was carried out at Tankardstown.

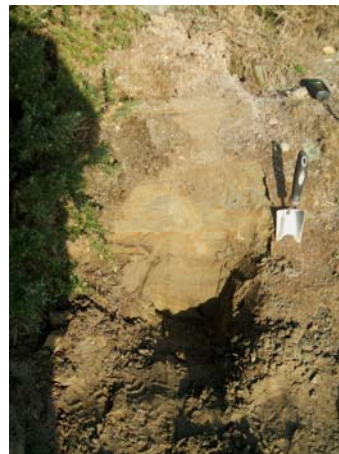
Three areas of solid waste have been defined at Knockmahon (Fig. 3). BUN-PROC01 is the main area of processing waste and includes mainly fine, red-brown waste (photo, right) that occupies the area where buddles and stamps were located. The second area of waste (PROC02) is located in the area where ore was unloaded from the trams, probably cobbled on the dressing floor and then run through the crusher. The waste in this part is generally covered by coarse, pebbly material but beneath this there is fine red-brown waste. The third area (PROC03) is the large flat grassed area in the floodplain of the river where, according to the reconstruction of Tietzsch-Tyler (2005), a fan of waste developed from the outwash from the processing area. The material analysed here was mainly soil at the base of the grass root layer.
