HOPE MINE

Background information

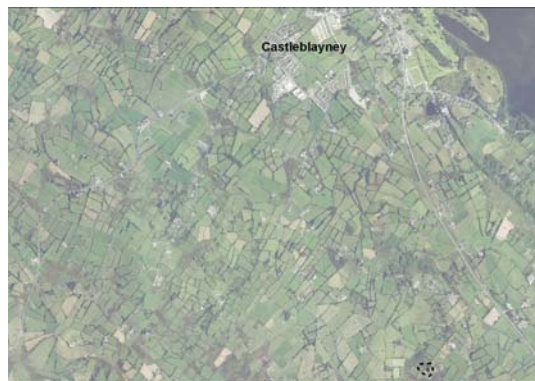
Hope Mine is located 3.5 km south of Castleblayney, less than 1 km from the N2. It is a small site of around 1.3 ha that includes an engine house chimney (photo, below) and a few small waste heaps, as well as the possible remains of a dressing floor. Most of the land around it is grassland. The site is now part of a farm although no grazing animals were observed in the course of site visits.
