# DOONEEN

## Background information

**Mine Name:** Dooneen

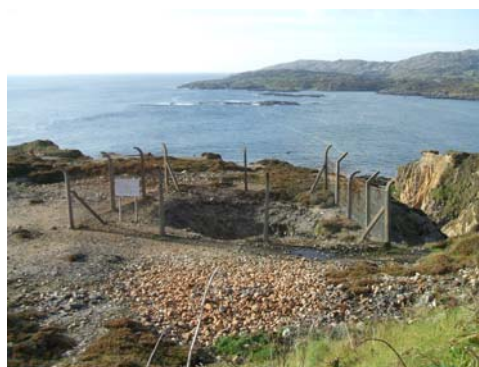
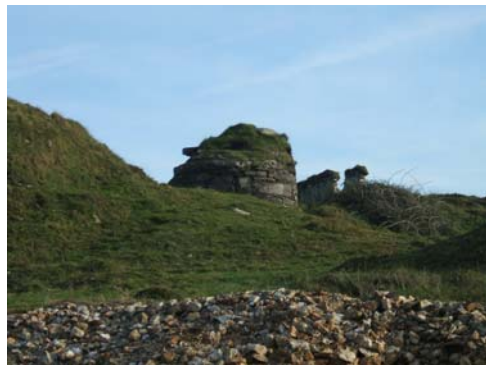
The site today (Fig. 1) is located on either side of the coast road that runs north from Allihies to Eyeries. The three shafts are still visible, surrounded by secure 2m+-high chain-link fence (right). As far as can be determined from outside the fences, the shafts have either collapsed or are filled near surface level by rubbish. Low ruined walls and the circular base of the chimney are all that remain of the engine house and the un-

named building behind it (left). The grassed-over footprint of a reservoir is clearly visible. A dressing floor extends out towards the cliff face.

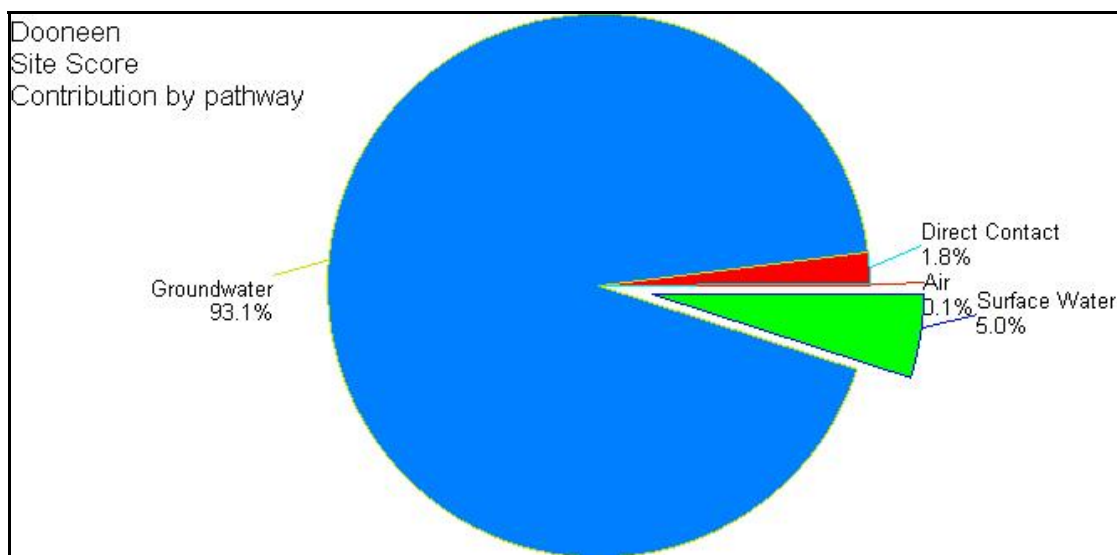
**Fig. 3 HMS-IRC Site Score, Dooneen: contribution by pathway**

In contrast to the situation for the Allihies District as a whole, but similar to that for Coom, the groundwater pathway (93%) is by far the greatest contributor to the site score at Dooneen (Fig. 3). The surface water pathway is a relatively minor contributor (5%). The relatively low contribution of the surface water pathway reflects the absence of any surface water courses in the area. Although the relative contribution from the groundwater pathway is high, nevertheless its absolute score (1.24) is very low given the volume of the solid waste on the site. There are no important aquifers in the area. Moreover, as the site is at the cliff edge, the potential for any contamination of groundwater is remote. The negligible contribution of the Direct Contact (1.8%) and Air (0.1%) pathways follows from the low concentration in solid waste of elements with high relative toxicity.
