# TASSAN

## Background information

**Mine Name:** Tassan

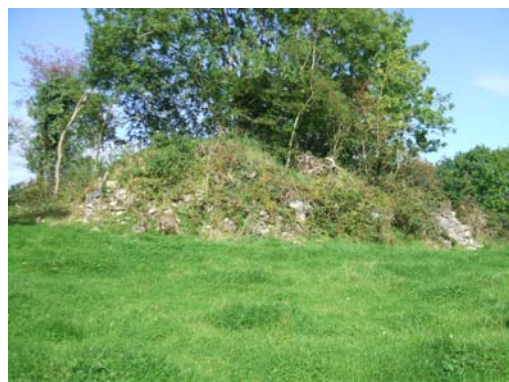
The mineralization was hosted by two lodes, each striking northnorthwest and dipping eastwards (Morris 1984), concordant with the regional fracture pattern. The mine appears to have extended to a depth of 160m (90 fathoms) below surface (Morris *et al.* 2002). The site contained a combined engine and crusher house (left) as well as mine offices, workshops and at least five shafts (Fig. 1) (Morris *et al.* 2002).

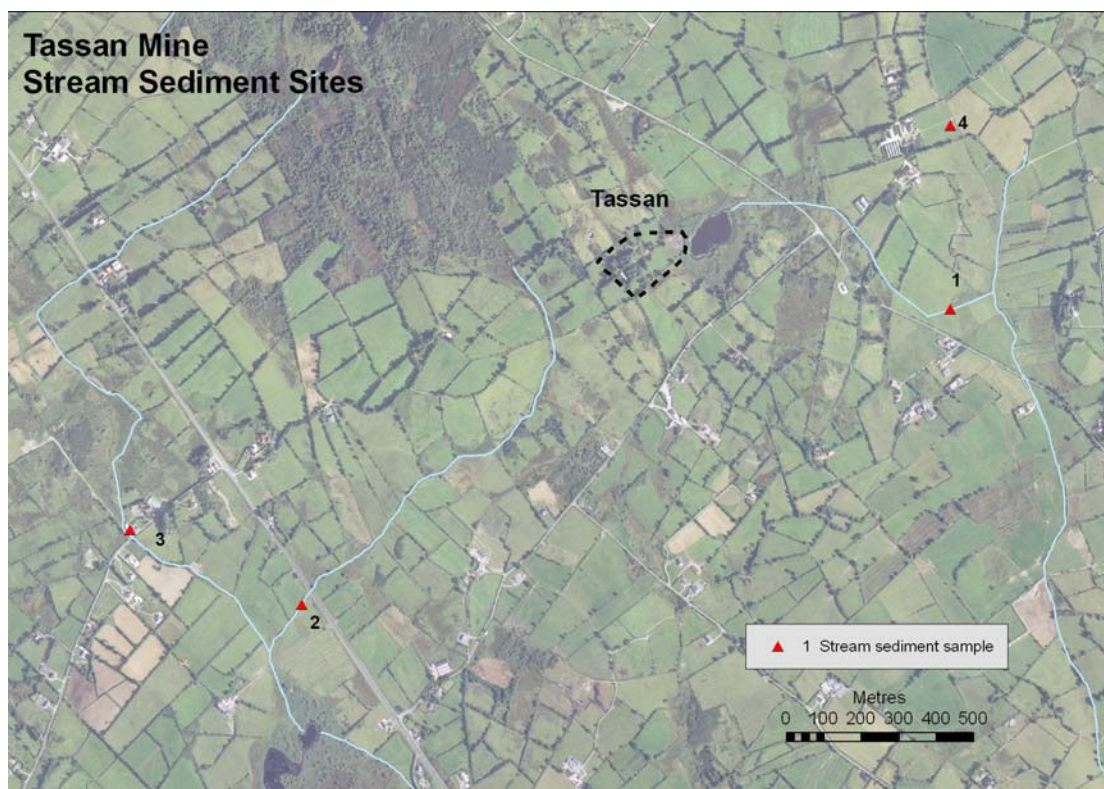
Fig. 2 Tassan stream sediment sample sites

A regional stream sediment geochemical survey was conducted in the Longford-Down Inlier in 1984. Four samples were collected in the vicinity of the Tassan deposit (Fig. 2), two downstream of it (sites 1 and 2 on Fig. 2) and two from streams that do not appear to drain any known mine sites. Table 2 summarizes the results for the four samples. All samples have concentrations of Pb and Zn that exceed expected background values, as indicated by the median concentrations for all samples taken from the Longford-Down Inlier. Those from streams draining the Tassan site or its immediate vicinity have significantly higher concentrations of both Zn and Pb, with 610 mg/kg Pb and 2865 mg/kg Zn 750m downstream of Tassan Lough. None of these concentrations exceed the limits for Pb (1,000 mg/kg) or Zn (5,000 mg/kg) used for this project. These limits are based on exposure levels considered safe for livestock.

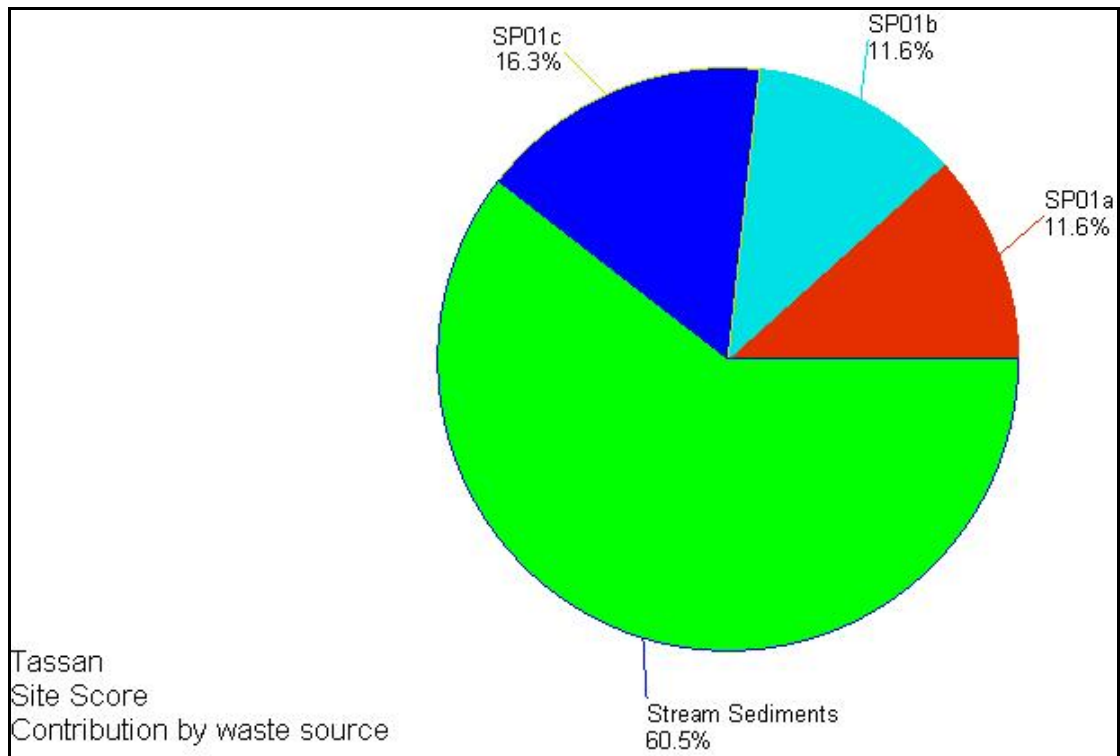
**Fig. 4 Tassan Site Score: contribution by waste source**

The total HMS-IRC Site Score for Tassan is 43, with contributions from the solid waste (17) and the stream sediments (26) (Table 4). The relatively high score for stream sediments (60% of the total; Fig. 4) reflects the extent of contamination of the stream system downstream of Tassan.

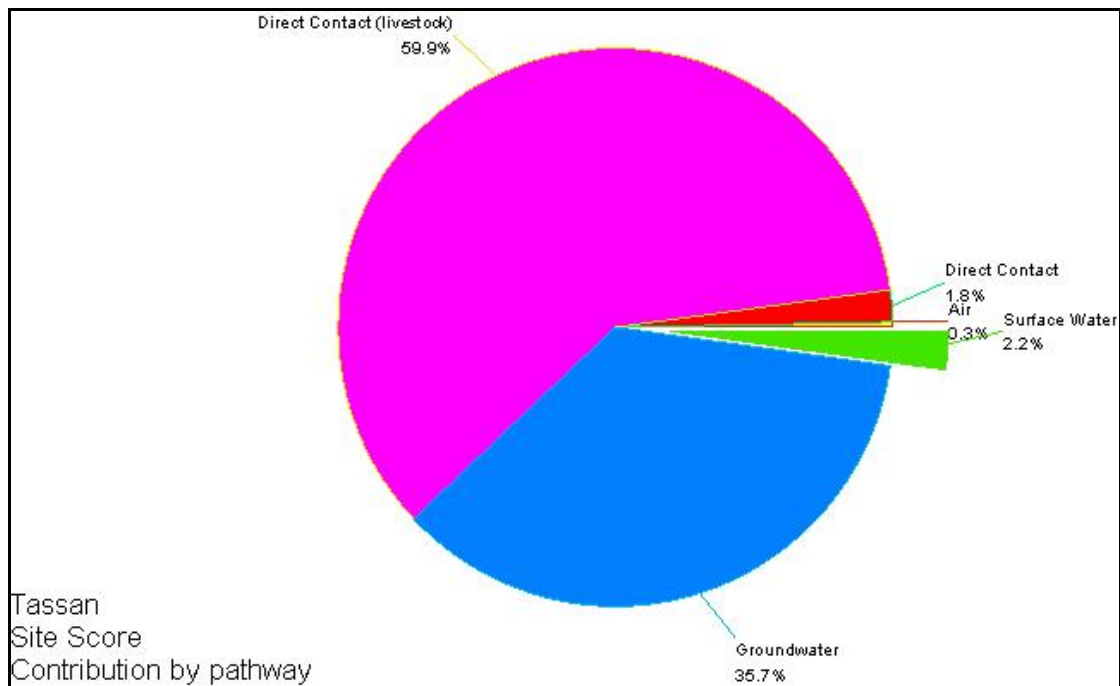
**Fig. 5 Tassan Site Score: contribution by pathway**

The large relative score for stream sediments means that the Direct Contact (livestock) pathway comprises 60% of the total pathway score for Tassan. The lack of any stream near or direct surface water drainage from the Tassan site means that the surface water pathway comprises a very small proportion (2.2%) to the overall site score, only slightly more than the Direct Contact pathway (Fig. 5). The groundwater pathway contributes 35.7% or most of the rest of the total pathway

score for the site (Fig. 5). The dominance of the Direct Contact (livestock) score is somewhat unusual. Without any stream sediment score at Tassan, the groundwater pathway would comprise almost 90% of the total pathway score.
