HERO

Mine Name: Hero

Mine District: Glendalough

Site Description and Environmental Setting

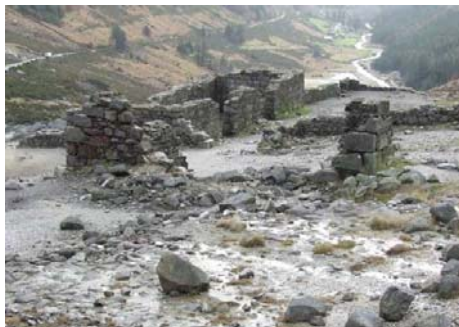
The 2.5 ha Old Hero site acted as a central processing area during the 19th century for various mines in Glendasan. Water was drawn via a *leat*, or wooden conduit, from the Glendasan River to power machinery and for ore separation processes. A track, interpreted as the foundation of the leat, is all that remains of this. Cobbing was done by hand in the cobbing yard (Fig. 1) before the ore was crushed in the crusher house (photo, above).

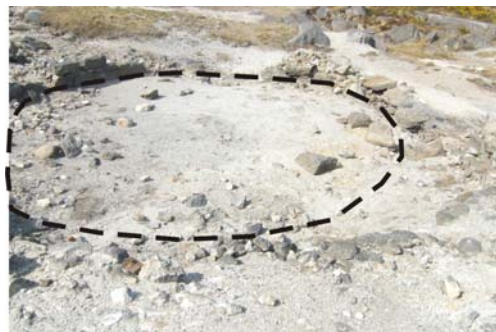
On the lower part of the site closer to the river, the ore was then crushed to a finer size by the stamps before being passed to the buddles (photo right, outlined). Buddles were circular tanks in which water was used to separate the lighter impurities from the heavier ore. Immediately beside the river is an accumulation of *slimes* (finely ground material produced during ore processing) in what was presumably once the location of a slime pit.

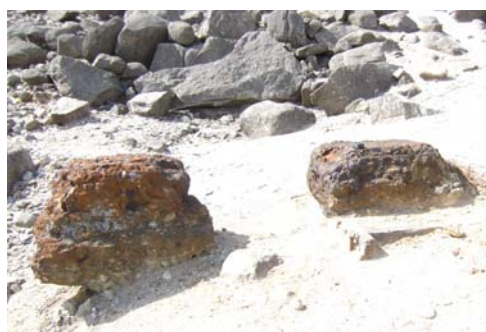
The upper floor of the site contains the ruins of a number of buildings. The most substantial are those of the cobbing house or yard, where waste material was removed from lumps of ore by hand using hammers ("cobbing"). Two buildings beside this were presumably offices or stores. The walls of the crusher house are still standing and, beside them, the wheel pit for the water wheel. An area of gravel waste in front of the crusher house is apparently a residue of the material produced by the crusher. On the lower floor of the site, the iron-oxide coated mortar stones of the stamps (photo, left) are present above the buddle area. The circular outlines of the buddles are still visible. Two shallow pits in this area (Fig. 1) may be related to the stamps.

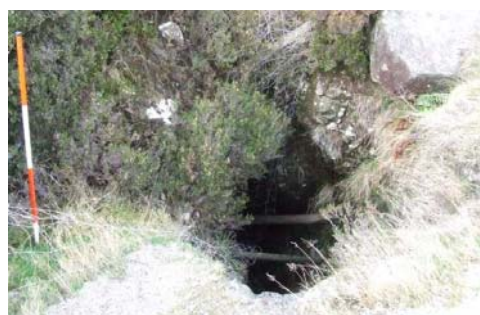
The southern edge of the site is covered by spoil, the waste rock left after mining of the Old Hero lode. Vertical wooden poles in the spoil are supports for a former ramp that led down to the adit from which the ore was raised. This was probably the Old Hero adit that was situated 40m south of the site boundary on Fig. 1. The extensive underground workings on Old Hero lode lie mainly below the western part of the site (Fig. 1). Several shafts are marked on old maps but none are visible today. There is one opening where a stope has broken through to the surface (photo, right).

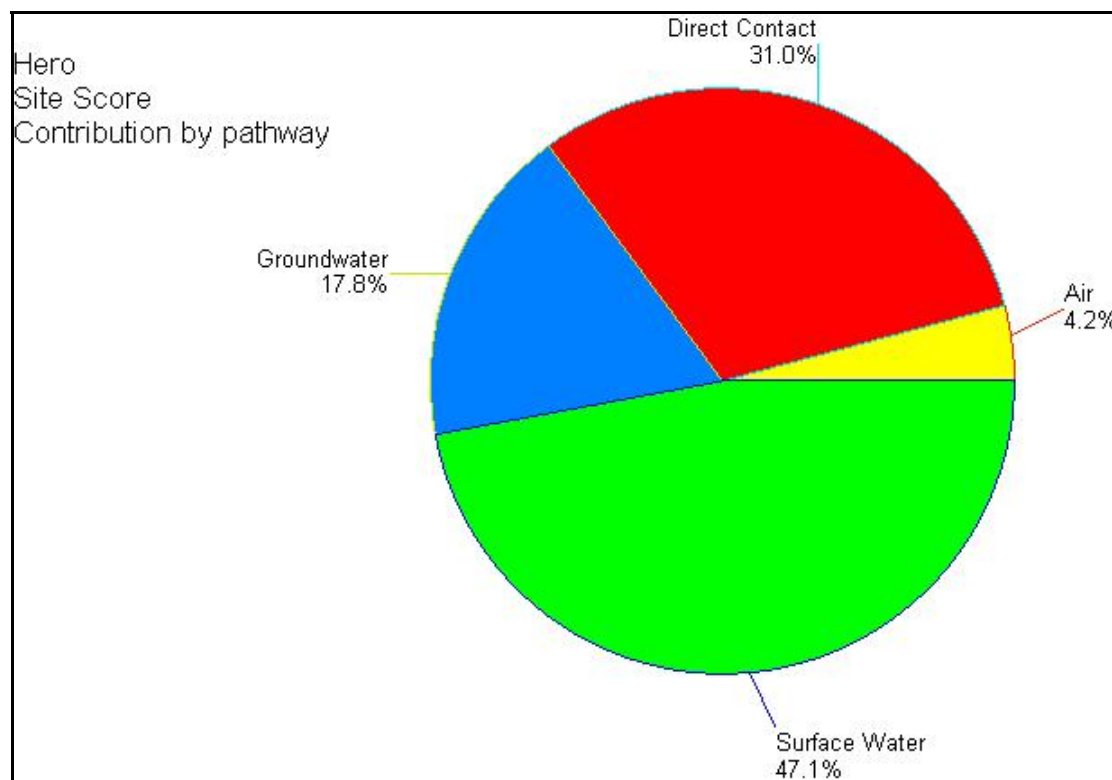
Fig. 6 HMS-IRC Site Score, Hero: contribution by pathway

Fig. 6 shows the contribution of the different pathways to the total site score at Hero. Pathways are the routes by which receptors are exposed to the hazard. As is the case for most sites in the Glendalough District, the surface water pathway (47.1%) is the main contributor to the site score, far outweighing the groundwater pathway score. This reflects proximity to the Glendasan River, in which the concentrations of Pb and Zn exceed the water standards, as well as factors such as poor aquifer quality, low population density and few wells, that minimize the groundwater pathway score (17.8%). The most unusual aspect of the site score is the very large contribution (31%) made by the direct contact pathway. Surface water and groundwater pathway scores are influenced by both the surface area and volume of the waste. The direct contact pathway is influenced only by the surface area. Where the surface area is in itself relatively large and where it is much greater than the volume, the relative importance of the direct contact pathway increases. Other factors such as the presence on site of visitors play a role but, in the case of Hero, the relatively large surface area and the 2:1 ratio of surface area to volume accounts for the large direct contact contribution.
