BALLYGAHAN

Background information

Mine Name: Ballygahan

Mine District: Avoca

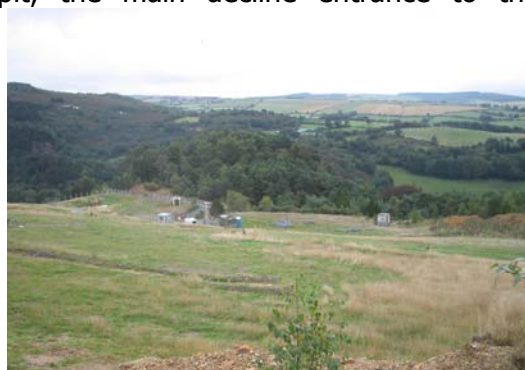
Fig. 1 Ballygahan: mine features

The Ballygahan site includes most of the area of the 20th-century West Avoca mine, including the site of the former open pit, the main decline entrance to the underground workings that underlie most of the area, the emergency tailings pond and the processing plant and workshops and offices area. Since closure in 1982, the mine site has been transformed through its use as a municipal landfill and associated rehabilitation works (photo, right). The site boundary (Fig. 1) encloses 22 ha of which the landfill site (6.5 ha) comprises almost a third.

The site lies along the main Rathdrum – Avoca road, the tailings pond to the east, bordering the Avoca River, and most of the remainder of the site occupying the side of the valley to the west. North and south of the site the steep valley sides are wooded and contain numerous houses. Some of these, notably those on the south side, were formerly mine staff accommodation (Fig. 1). The site rises to the west and is bordered on the northwest by Ballymurtagh mine site and to the west and southwest by farmland, mainly pasture. Ballygahan and Ballymurtagh were initially two separate mines but have been linked by the Margaret Adit since the mid-19th century. In the 20th century, they were part of one large site, West Avoca.

in West Avoca. The water rises via two reservoirs along the shaft before flowing along the **Road Adit** to the Avoca River (Fig. 1). The Road Adit has been rehabilitated in recent years by Wicklow County Council: it was cleaned out, the entrance reinforced and it is now securely gated (photo, right). A parshall flume with an infrared warning sensor is used to monitor water levels. West of the old open pit area and modern landfill site are the **Twin Shafts** and their associated engine houses. The Engine shaft lies southwest of the Drawing shaft. One engine house is represented by part of a wall but the other, the Drawing Shaft engine house, has an intact chimney and has recently been conserved (photo, left). The shafts were begun in the 1850s as part of the westward extension of Ballygahan mine and reached their final depth of 300m below surface in 1864. They were used for pumping water (Engine shaft) and raising ore (Drawing shaft). In the 20th century,

The building north of the road at the site entrance was built as the main office – it is now being converted for heritage use (Fig. 1). Behind this are old staff hostels or apartments. The Director’s Lodge, mine manager’s house and staff housing were located along the Red Road south of the site. Two intact buildings across the road from Whitebridge were used as a laboratory and garage by St. Patrick’s Copper Mines Ltd.. This company also constructed most of the mine buildings used for processing ore on the site, including the mill and workshops (photo, left). These buildings were also used by Avoca Mines Ltd. and were dismantled after closure of the mine. The area previously occupied by the mill and workshops was backfilled with spoil and covered by a thick layer of imported topsoil before revegetation by the County Council. Several concrete pads beside the road that winds up to the open pit site are all that remain of the workshops. Of the mill there is no trace.

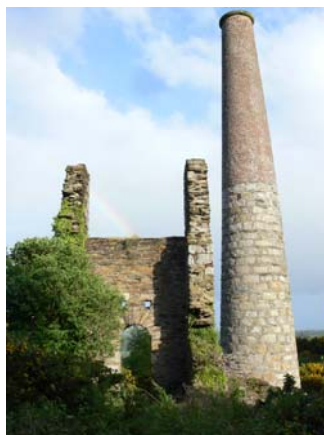
the shafts were used solely for ventilation and as an escapeway. Both are capped with reinforced concrete slabs. About 50m northeast of the Twin Shafts is the conserved chimney of the **Tramway Engine house**, used for hauling the wagons of the small railway built in the 1840s to carry ore to the port of Arklow. The **Ballygahan Engine house**, on the north edge of the former open pit, is also included in this site. It comprises an intact chimney and three partly intact walls (photo, right). The remaining 19th

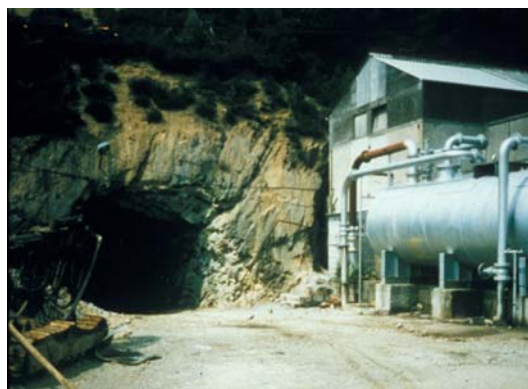
St. Patrick's Copper Mines Ltd. (1958-62) constructed a large number of buildings on and around the site. Many of these were later used by Avoca Mines Ltd. (1969-82). In addition, it constructed the main decline, the **Knight Tunnel**, that was used to enable vehicles to gain access to the underground workings (photo, right). This was also

subsequently used by Avoca Mines Ltd.. The 5m high and 5m wide tunnel entrance was sealed with a concrete plug after closure of the mine in 1982.

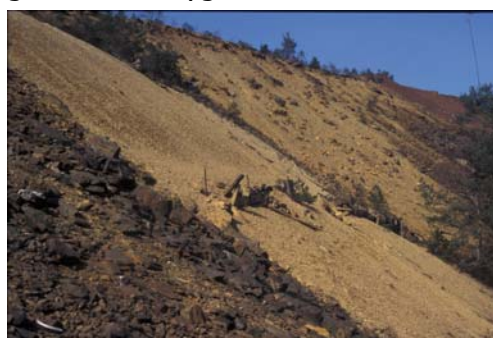
Apart from the open pit, now filled in and the surface grassed, several large spoil heaps are the most obvious remnant of mining on the Ballygahan site. The red-brown spoil forms a prominent, steep embankment along the side of the road (SP39a, photo, right). Above the site of the Knight Tunnel entrance is another large spoil heap (SP33), now considerably overgrown by pine, heather and gorse. The emergency tailings pond (SP41), seen when active at bottom of photo (above), is another waste pile of considerable size. The exact thickness is uncertain but is estimated to be around 2m based on the height of the embankment and retaining wall above the river. The emergency tailings pond was also rehabilitated by the council, using a similar technique of covering it with imported topsoil and seeding with grass. This part of the site was to be developed as a Miner’s Park but it is now growing wild and the surface has been extensively colonized by gorse and other species. Table 1 gives estimates of the area and volume of the waste heaps on the Ballygahan site.

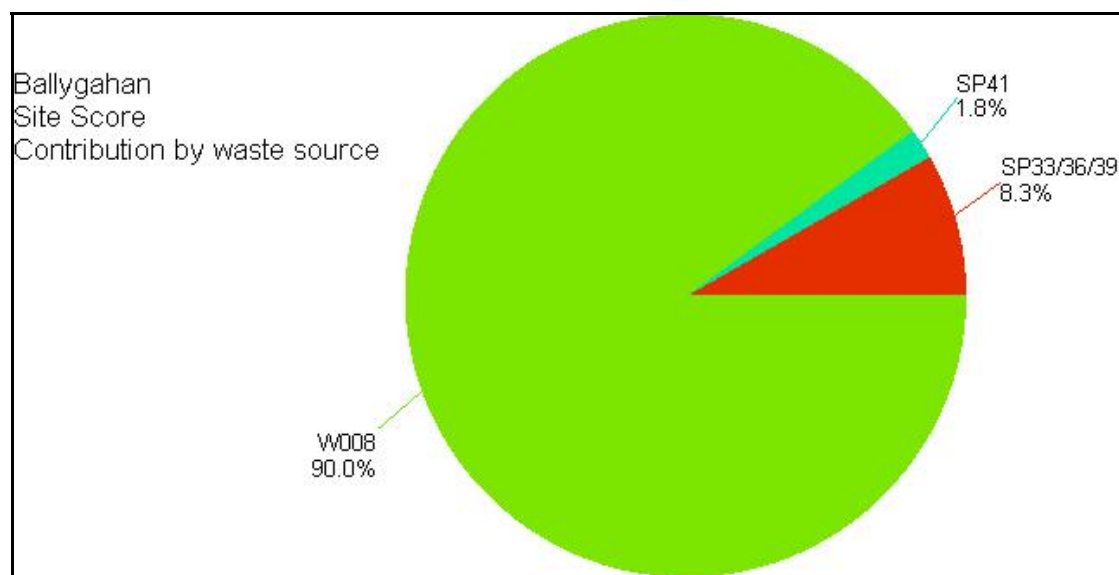
Fig. 3 Contribution of individual waste sources to Ballygahan Site Score

The total HMS-IRC Site Score for Ballygahan is 399 (Table 4). The Road adit discharge accounts for 90% of this score (Fig. 3). No analysis was carried out on SP33 or SP39a but data from adjacent heaps, SP34 and SP39b, respectively, were used instead. The emergency tailings pond was not analysed either so data from Shelton Abbey tailings pond was applied. The contribution of the solid waste to the total score is very low – this is similar to the situation in Tigroney West where the Deep adit accounts for 84% of the site score.

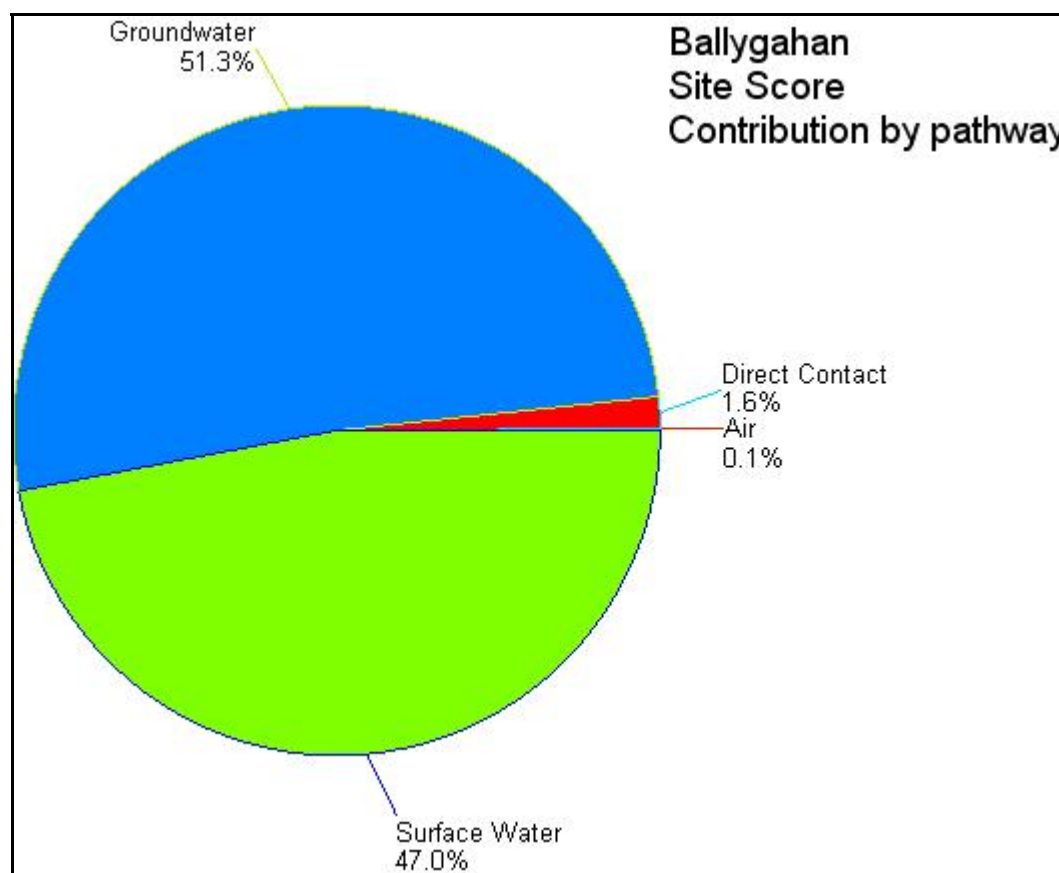
Fig. 4 Contribution of individual pathways to Ballygahan Site Score

Fig. 4 shows the contribution of the different pathways to the total site score at Tigroney West. Pathways are the routes by which receptors are exposed to the hazard. Groundwater and surface water pathways make an almost equal contribution to the score which largely reflects the contribution of the Road adit discharge. In Tigroney West, the Deep adit surface water pathway score exceeds that for groundwater since the length of impacted river is deemed to be greater because the Deep adit is a further 1 km upstream. The direct contact and air

pathway scores are negligible, reflecting the minimal input from the solid waste heaps.
