MOUNTAIN MINE

Background information

Mine District: Allihies
Mine Name: Mountain Mine
Alternative Names:

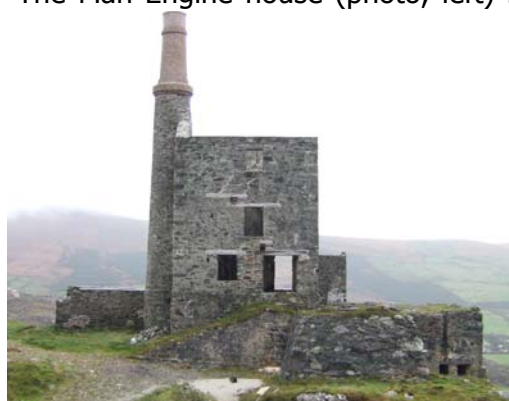
The Man Engine house (photo, left) is the only extant building on the site and an important landmark in the area. Built in 1862 as a means of transporting miners to and from the underground workings, it was the only engine house of its kind built in Ireland. A conservation project was completed in 2003. Other buildings on the site include the remains of the 1920's crusher house and those of several nissen huts that served as accommodation for miners during the Can-Erin exploration in 1956-1961 (Fig. 1).

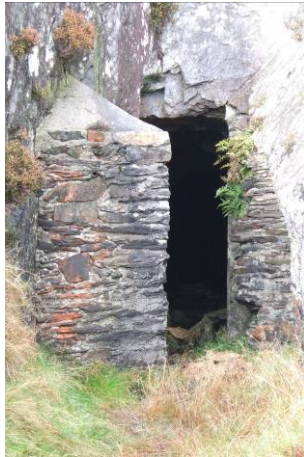
The workings at Mountain mine are extremely extensive. Mining of the vein system initially began at the surface before continuing underground, leaving large, deep excavations at the surface. Some stopes were carried through to the surface from underground. Several open shafts remain, notably the engine shaft immediately in front of the engine house (Fig. 1). Excavations and shafts are surrounded by a 2m-high chain-link fence.

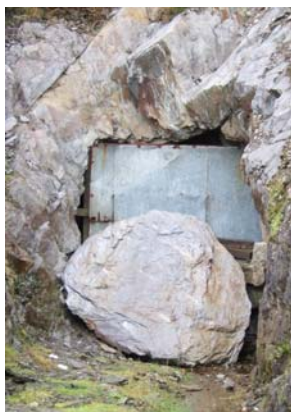
The Main adit (photo, left) and Chamber adit discharge mine water. The Main adit does so continuously whereas the Chamber adit discharge has been observed only in winter. The Magazine adit also discharges water but this is assumed to be groundwater that seeps into the adit through the roof and walls. This water seeps into the ground east of the adit. Flow rates of 0.25 and 3.4 l/s were measured at the Main adit in summer and winter, respectively. Total mine water discharge rates from Mountain mine, as measured on the same days in the drainage channel near the road at the southern extremity of the site, were almost double those of the Main adit, 0.45 and 6.4 l/s, respectively. Although the

Chamber adit makes a small contribution in winter, most of the additional discharge implied by the total discharge readings appears to come from a buried conduit just east of the crusher ruins. This conduit coincides with a drainage channel marked on 1920s maps but it is not clear what workings are being drained.

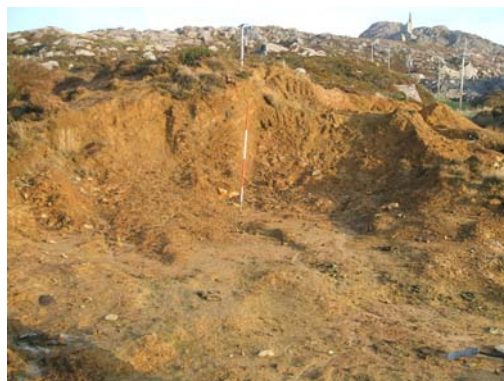
Solid mine waste is widespread over the site but waste heaps are relatively small compared to those seen on other sites in the country (Table 1). Whether waste was returned underground after dressing is not known. Fine, crusher waste was washed down in streams to the sea at Trá na mBan where it forms the raised beach. Coarser waste is scarce on the mine site although a small slag heap (SP06c, Fig. 2) is present close to the engine house. Most of solid mine waste is found in relatively thin accumulations below the site of the crusher house and in thicker (2m+), distinctive red-brown accumulations around the discharge channel at the southern extremity of the site (photo, right). Over the course of the project, excavation waste from house construction has been dumped on the site in the vicinity of the Main adit and this is now threatening to obscure the mine features in this area.
