LETTER

Mine Name: Letter

County:
Cork

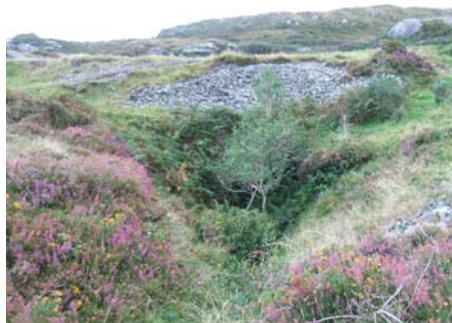
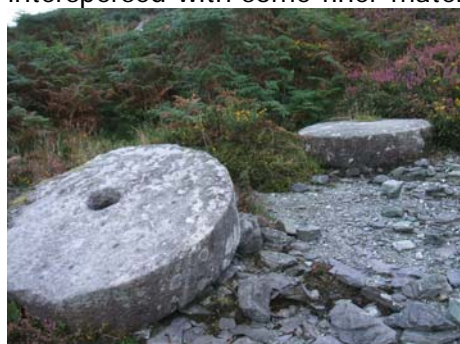
There are few mining remains on either the Cu or Ba mine sites. A large water tank was recently installed at the latter site and it is not clear how much the site owes to this phase of construction or the previous phase on mining. None of the marked shafts were located and were presumably filled in. The Cu mine site contains the remnants of a dressing floor around the site of the demolished chimney. A cutting leads south from it and may have been an adit (photo, right). A depression in the

ground marks the site of a shaft, presumably Colonel Hall's original working. The dressing floor contains a small volume of coarse-grained processing waste interspersed with some finer material that has been winnowed out and deposited by rain water. Solid waste volume is estimated to be 286 m³, with a surface area of 572 m². Two large mill stones are presumably remainders of the crushing machinery on the site. The Cu mine is on a private farm. The land is for the most part hilly, with at most thin soil cover, covered in heather and grass. Cleared areas on flatter ground are used for cattle grazing.
