# RUPLAGH

## Background information

## Site Description and Environmental Setting

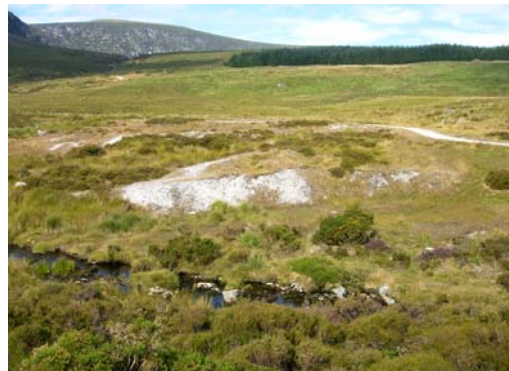
**Fig.1 Ruplagh Mine Features**

Ruplagh is at the western end of the Glendasan Valley and includes some of the most remote mine sites in the Glendalough district. The site as defined for the HMS-IRC project spreads over an area in excess of 8 ha in an area of moorland largely used for sheep pasture and hill walking. It incorporates the old mine sites of Old Ruplagh (photo, right), North Ruplagh and West Ruplagh (Fig.1). Smaller satellite sites include those around Cleme's Adit and Shaft and Campbell's Adit and Shaft (Fig.1).

A number of ruined mine buildings still stand on the Old Ruplagh site. The original function of most of them is unknown. The most impressive of them appears to be an engine-house ruin (Fig.1), now consisting of exterior and interior stone walls and a well preserved wheel pit (photo, right). The highest wall is 2.5 m high. This building is now part of a farm enclosure and is used as a sheep shelter.

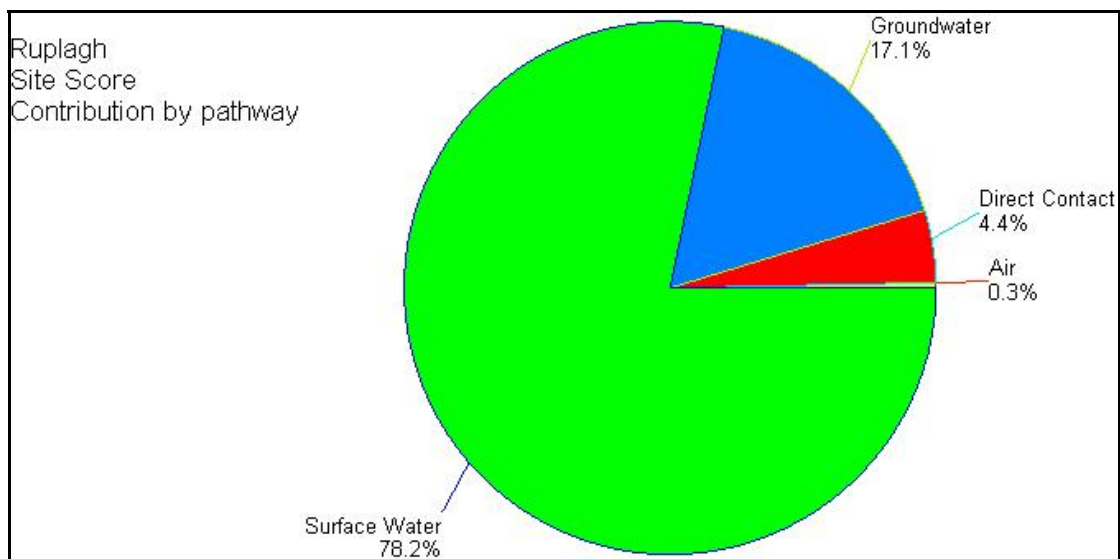
**Fig. 4 HMS-IRC Site Score, Ruplagh: contribution by pathway**

Fig. 4 shows the contribution of the different pathways to the total site score at Ruplagh. Pathways are the routes by which receptors are exposed to the hazard. As is the case for most sites in the Glendalough District, the surface water pathway (78.2%) is the main contributor to the site score. This reflects proximity of all heaps to the Glendasan River or to drains that link them directly to the river, the remoteness of the site reduces the influence of the groundwater pathway (15.5%) because the low population density means there are few wells and few inhabitants that can be affected by contaminated groundwater. The Direct Contact pathway is low in spite of the ready accessibility of the site and the popularity of the area with tourists and walkers. This is mainly a consequence of the relatively low metal concentrations in the waste – there are no accumulations of metal-rich processing waste at Ruplagh - and the relatively low surface area of the heaps.
