LUGANURE – HAWKROCK

Background information

Mine Name: Luganure & Hawkrock

Mine District: Glendalough

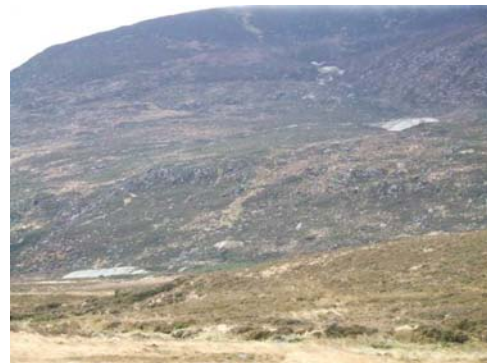
Luganure and Hawkrock mine sites (top right and bottom left, respectively, in photo, right) are at the western end of the Glendasan Valley on the northern slopes of Camaderry Mountain. They lie directly south of Ruplagh and, like that site, include some of the most remote sites in the Glendalough district. The sites as defined for the HMS-IRC project cover a total of 4.3 ha, of which 3.4 ha is accounted for by Luganure and 0.9 ha by Hawkrock. In addition to the Luganure and Hawkrock mine sites themselves, smaller satellite sites include those around North Luganure Adit and Cape Horn Shaft (Fig. 1). The Luganure site as well as the workings at the North Luganure Adit and Cape Horn shaft were developed along the Luganure Lode while Hawkrock was developed along the southern part of the Ruplagh Lode.

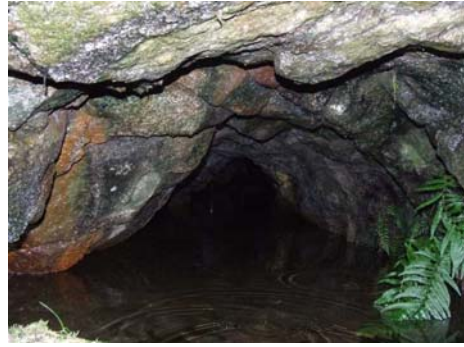
As is the case with the Ruplagh site, Luganure and Hawkrock are remarkable for an abundance of extant shafts and adits. The adits are in various states of collapse but their entrances are generally well defined. Some, such as the Luganure Adit (photo, right) or Hawkrock Adit, are accessible for a short distance. All of the shafts are collapsed and/or filled in or else they are flooded and of uncertain status. Both Luganure Adit and Hawkrock Adit discharge small flows of mine water. Reed-filled channels leading from both North Luganure Adit and Cape Horn Shaft suggest these two structures also discharge mine water although none was observed directly. All mine water discharged by shafts or adits ultimately flows into the stream that flows down from Lough Nahangan to the west.

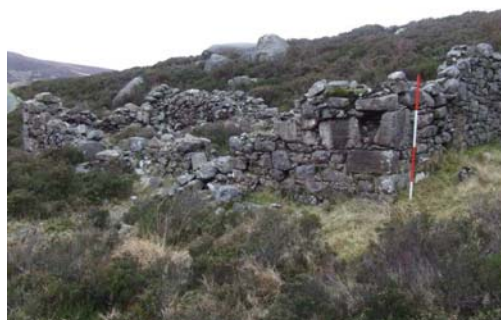
A number of ruined mine buildings still stand on the two sites. At Luganure the low stone-walled ruins of four mine buildings stand on the flat area north of Luganure Adit (photo, right). The largest of them is 12 x 6 m, divided into two rooms. Most appear to have been offices rather than crusher or other processing buildings. At Hawkrock, the ruins of two small buildings stand at the western end of the waste heaps – they are also likely to have been offices rather than processing buildings.

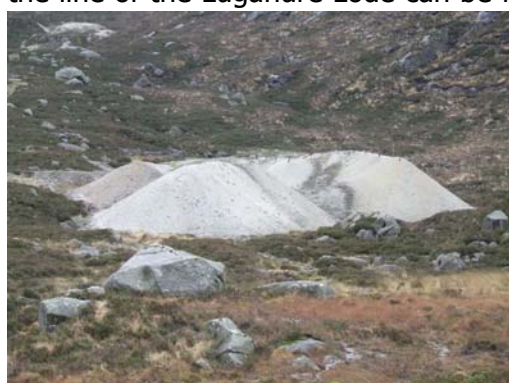
The waste is typically white or grey quartz- or granite-rich material, similar in appearance to waste elsewhere in the district. The largest waste heaps are those immediately below the Luganure Adit (photo, left). The front lobes of these heaps are around 10m in height. As far as is known, the ore mined at Luganure was not processed there. Initially a tramway ran to the Old Hero Processing site via what is now a walking track that links the two sites. In later years, the ore was taken out from the southern side of the mountain and processed at the Glendalough Valley site. The calculated area and volume of waste heaps are given in Table 1.

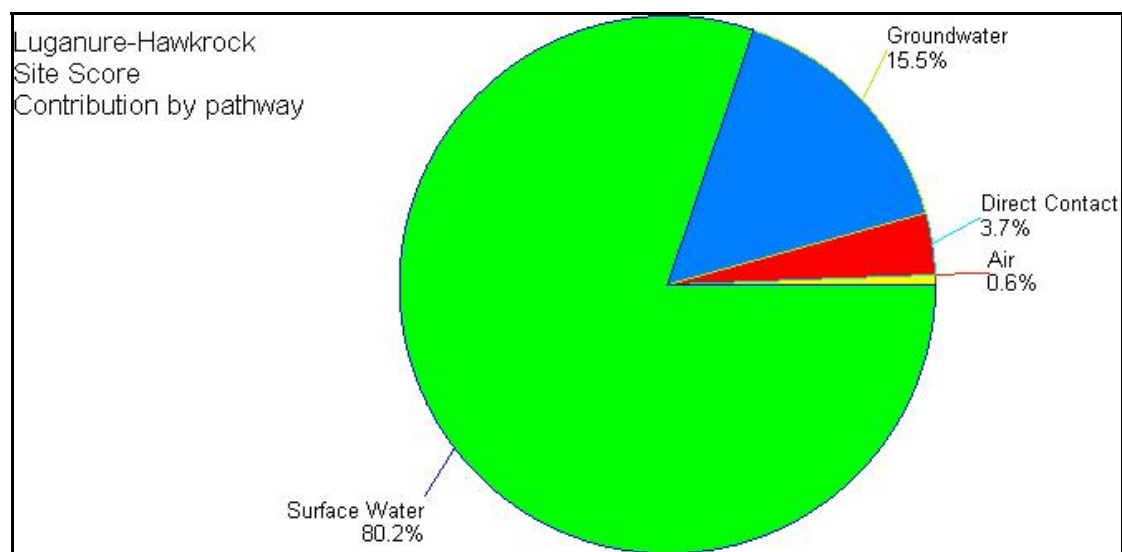
Fig. 3 HMS-IRC Site Score, Luganure-Hawkrock: contribution by pathway

Fig. 3 shows the contribution of the different pathways to the total site score at Luganure-Hawkrock. Pathways are the routes by which receptors are exposed to the hazard. As is the case for most sites in the Glendalough District, the surface water pathway (80.2%) is the main contributor to the site score. This reflects proximity of all heaps to the stream system or to drains that link them to the stream system, as well as the fact that concentrations of some metals in the stream at Hawkrock exceed the surface water standard. In addition, the remoteness of the site reduces the influence of the groundwater pathway (15.5%) because the low population density means there are few wells and few inhabitants that can be affected by contaminated groundwater. The Direct Contact pathway is low in spite of the ready accessibility of the site and the popularity of the area with tourists and walkers. This is mainly a consequence of the relatively low metal concentrations in the waste –

there are no accumulations of metal-rich processing waste at Luganure-Hawkrock - and the relatively low surface area of the heaps.
