BALLYCORUS

Background information

Mine Name: Ballycorus

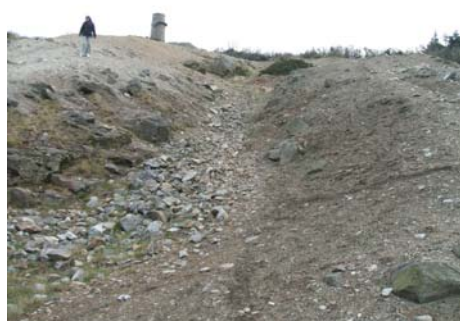
Mining began in the early part of the 19th century with shallow workings recorded in 1807 (Cole 1922). The early workings took place on what is now the opencast site (photo, left), located directly below the flume chimney, apparently on a particularly rich bunch of ore, located at the contact of the granite and the schist. Subsequently the Mining Company of Ireland (M.C.I) took over the site and worked the mine intermittently between 1826 and 1863.

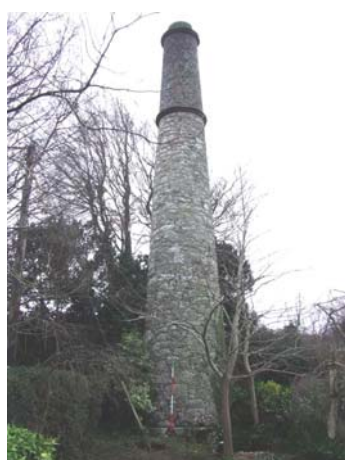
hill between the mine and the smelter (Fig. 1). The 1857 shot manufactory chimney is still standing (photo, left) and some houses and gardens are located on or beside

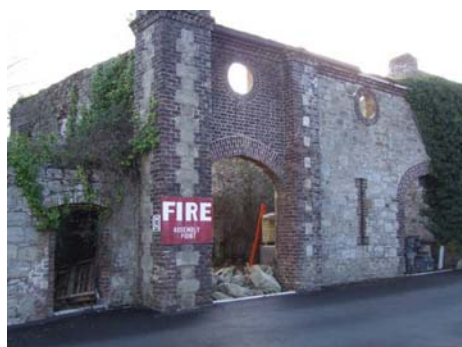
the site of the manufactory. Some of the houses incorporate elements of the original mine buildings (Fig. 2). The smelter site is now in use by a solvent factory (Fig. 3; photo, below left). A number of other original buildings are still visible around the site. The smelter chimney on the top of the hillside is intact as is much of the flue that carried the Pb-rich smoke to the chimney from the smelter (Fig 1). Some of the old smelter buildings are in use by the solvent factory or as residences.

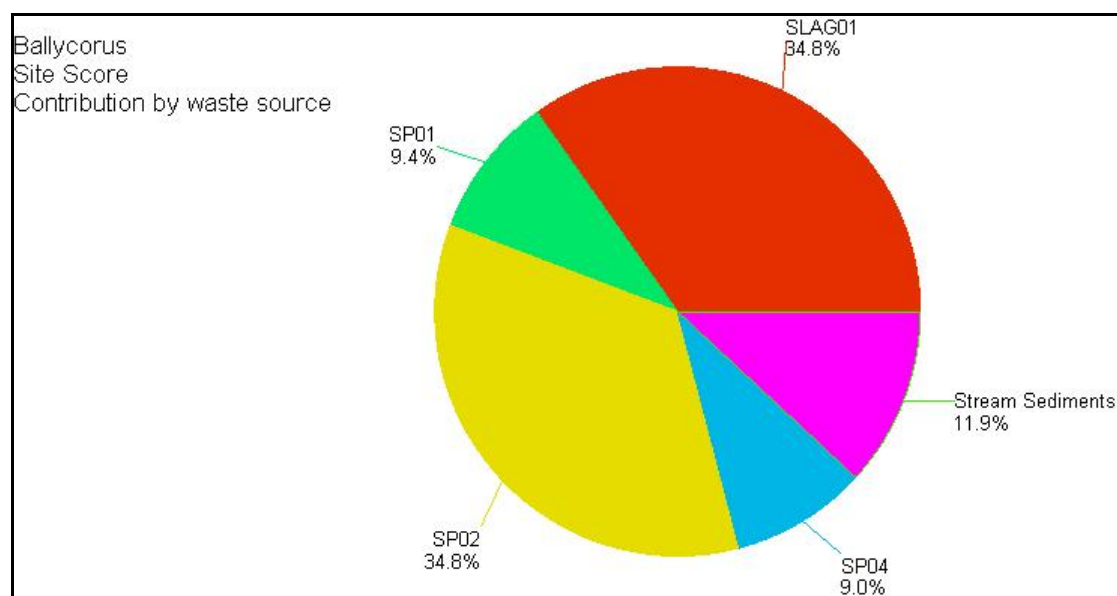
Fig. 5 HMS-IRC Site Score, Ballycorus: contribution by waste source

The total HMS-IRC Site Score for Ballycorus is 244 (Table 6). The high Pb concentration of SP02 and SLAG01 as well as their higher volumes give them both higher hazard scores than the other waste heaps. The relatively large area of SP02 and its location on a site popular with visitors gives rise to an extremely high direct contact pathway score relative to the other waste heaps. The slag waste beside the smelter site has a much lower direct contact pathway score than SP02 but it still has a high total score because its proximity to the Loughlinstown River gives it a relatively high surface water pathway score (Table 6). These two waste heaps contribute almost 70% of the total site score (Fig. 5). The relatively high Pb concentration in stream sediments over an extended length of river accounts for the relatively high contribution from this source.
