FOXROCK

Background information

Mine Name: Foxrock
Mine District: Glendalough
Alternative Names:

Site Description and Environmental Setting

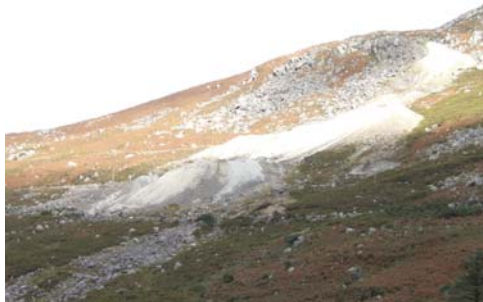
Foxrock mine site is located on the north side of the Glendasan River, on the slope above the Wicklow Gap road (Fig. 1). It includes most of the adits and spoil heaps related to mining along the Foxrock lodes as well as the Hollyrock lode. A considerable volume of spoil lies on the steep slope above the road. Mine water discharging from two adits has formed a pond on one heap. This water then drains through the heap into a roadside drain. A number of ruined mine buildings still stand on the site. The area is popular with walkers and sightseers. The site (photo, left) covers an area of about 5.6 ha and is accessible via a track leading up from the Wicklow Gap road.

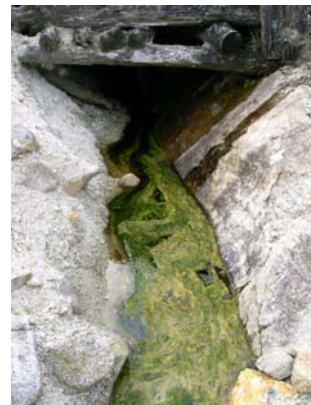
Of the eight extant adits identified on the site (Fig. 1), five discharge mine water. The volume of water discharged by the adits ranges from less than 0.1 l/s to more than 3 l/s from the Foxrock 3rd Adit (photo, right). In each case, the mine water ultimately flows into a roadside ditch beside the Wicklow Gap road. This water then flows beneath the road and down the hillside, crosses St. Kevin's mine site and flows into the Glendasan River. Although most adits have visible openings, all have collapsed to a greater or lesser degree within metres of the entrance.

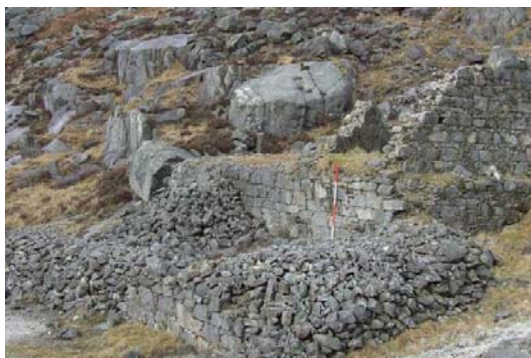
Two ruined two mine buildings remain on the site (Fig. 1). The main building was a crusher house (photo, left) – the remnants of thick stone walls define the footprint of the building but much of it has been reduced to a height of one metre or less. The other, smaller building, a short distance west of the crusher house, has a well preserved fireplace. This together with remnants of plasterwork suggests it was a manager's office.

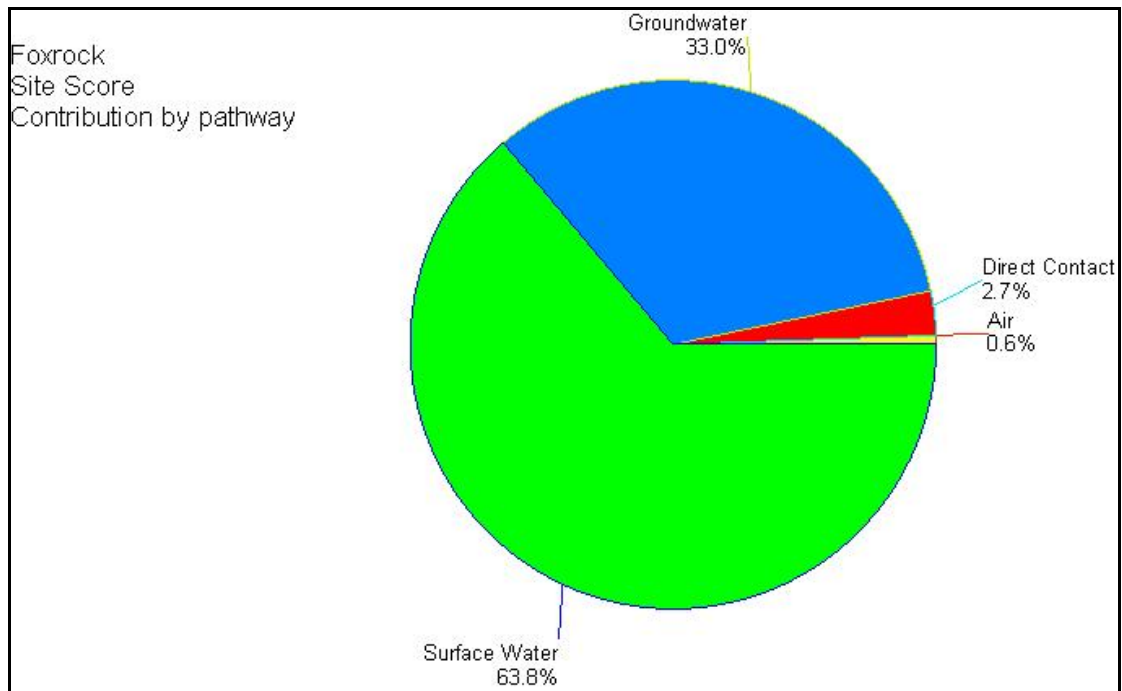
Fig. 5 HMS-IRC Site Score, Foxrock: contribution by pathway

Fig. 4 shows the contribution of the different pathways to the total site score at Foxrock. Pathways are the routes by which receptors are exposed to the hazard. As is the case for most sites in the Glendalough District, the surface water pathway (63.8%) is the main contributor to the site score. This reflects proximity to the Glendasan River, in which the concentration of some elements exceeds the water standards, as well as factors such as poor aquifer quality and low population density, and hence few wells, that minimize the groundwater pathway score (33%). The Direct Contact pathway is low in spite of the ready accessibility of the site and the popularity of the area with tourists and walkers. This is mainly a consequence of the relatively low metal concentrations in the waste – there are no accumulations of metal-rich processing waste at Foxrock - and the relatively low surface area of the heaps.
