SLIEVE ARDAGH COALFIELD

Background information

Mine District: Slieve Ardagh

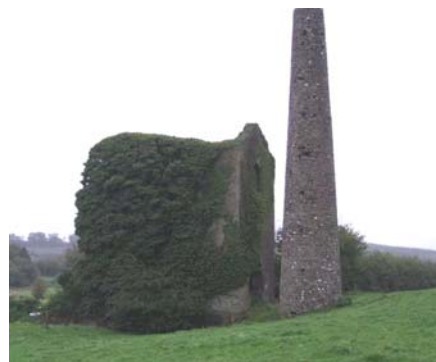
The Ballynnty site (c. 13 ha) lies immediately south of the R691, 1 km east of Ballynnty village (Fig. 4). The Mardyke site (2 ha), with its extant chimney and engine house (photo, above), is a further 600m southeast. Mardyke became the first major centre of coal mining in Slieve Ardagh when the Mining Company of Ireland opened a colliery there in 1826. It closed in 1833 and little or no trace remains of the mine workings. Ballynnty was last operated in the 1940s by Mianrai Teoranta. Three inclines were used at Ballynnty to provide access to underground workings that extended 2km northeast to Lickfinn. The entire operation, including machinery and buildings, was removed in 1948 to Copper, west of Ballingarry village, where a new colliery was established.

The Mardyke site is on a farm close to the farmhouse and outbuildings. The ivy-covered engine house and chimney stack are still standing (photo, previous page). However, the chimney is a hazard: its wall bulges in the centre and is cracked, it lacks a lightening conductor and blocks have already fallen from the top. The engine house is also deteriorating: it is leaning, has cracked walls and missing lintels and lacks a lightening conductor.

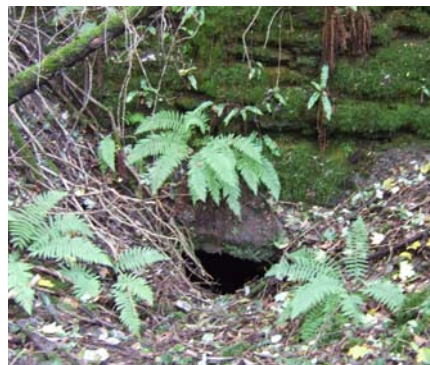
Very few traces of mining remain on the Ballynulty site. It is cut by the Ballynulty River that flows west toward Ballynulty village. The mine workings were mainly on the south bank of the river and this part of the site has been largely reclaimed for pasture farming. Two partly vegetated waste heaps are the most obvious signs of mining. Several concrete structures, now serving as a store area for silage and other feed, are probably remnants of Mianrai Teoranta's time on the site. On the north bank of the river, two new houses have recently been built. Within the wooded area along the river bank, an in-filled decline portal (photo, right) can be seen. The remains of several coal wagons are strewn about the river bed. The main drainage adit for the northwestern side of the Slieve Ardagh coalfield, called the Ballynulty-Lickfinn adit (photo, below), discharges into the river at the western edge of the site. An open brick-lined air shaft to this adit is in the centre of a copse of trees, protected by a low barbed-wire fence, but access to it is easy. The Mardyke drainage adit discharges into the same river upstream of the Ballynulty site – the adit itself is invisible in overgrowth. Both adits discharge considerable volumes of water all year round. A rough estimate of flow in the Ballynulty-Lickfinn adit in March 2007 gave 160 l/s. North of the site, the Meadow Pit shaft (Fig. 4) is capped although the cap appears to be unstable.

However, the fencing around the shaft is secure. The Knockanure shaft is infilled and has a small waste heap beside it.

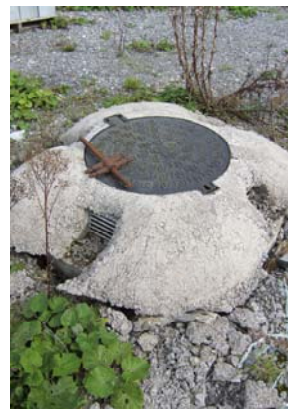
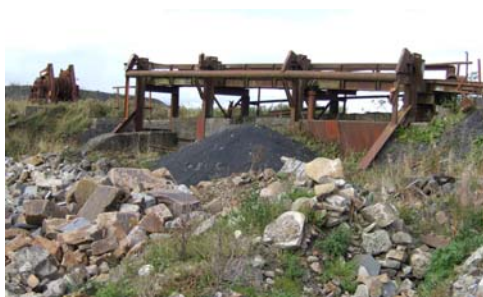
inadequate. Despite relatively high prices for anthracite and investment by the Industrial Development Authority, Tipperary Anthracite went into receivership in December 1983. Access to the underground workings was via the main decline adit; a second return drift allowed for circulation of air through the workings. Both these adits were capped in recent years (photo, right) by the Office of Public Works in response to the concerns of local residents.

The site also contains the remains of several mine buildings, a large waste heap and a small lagoon used as a drainage sump, possibly for the washroom facilities. Buildings include the concrete structure of the lamp room and the steel-framed corrugated iron-enclosed workshops (photo, previous page). The remains of the winch system and loading platform (photo, left) are in front of the large

The site is privately owned. Access is easily gained over a metal farm gate or low walls. The adits have been covered by locked manholes set in a concrete cap and there is thus no ready access to underground workings. However, there are several potential mine-related hazards on the site. The northwest face of the waste heap is steep (45°) and represents a fall or collapse hazard. The workshop building is in a state of disrepair, with part of the roof missing. The stability of the winch gear is

uncertain. The lagoon, of unknown depth, is easily reached over a low chain-link fence barbed-wire fence.

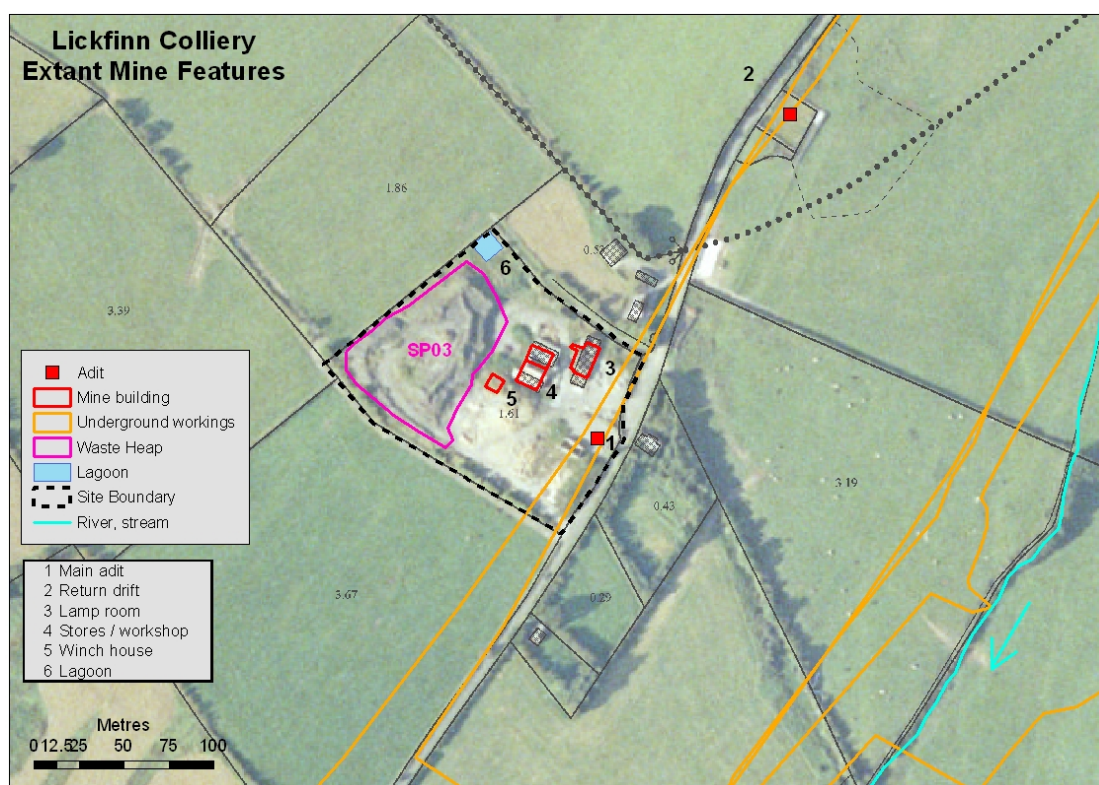
Fig. 5 Lickfinn: mine features

The Lickfinn site (Fig. 5) occupies 1.6 ha by the side of the road, 2km northeast of Ballynulty and 5km southwest of Gorteen. It is immediately adjacent to a number of houses that lie along the same road. The surrounding land is mainly cattle pasture. The site dates from the period 1978 to 1983 when first Kealy Mines and then Flair Resources, trading as Tipperary Anthracite, held the mining lease. The site is small as the processing operation was carried on at Gorteen. Both operations were under-resourced and equipment, especially for dealing with serious flooding problems,

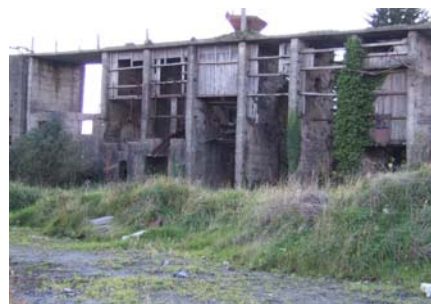
The site is dominated by the tall concrete gantry from which mining operations were run (photo, above) and by its very large waste heap. The waste heap has an estimated volume of 160,000 m³ (British Mining Consultants 1982). Other features on the site include large concrete settling tanks, the remains of the mine offices, winch gear and a large metal chute (photo, right). Only the footprint of the processing plant remains. The extensive poured concrete hardstand beside it is strewn with the remains of truck axles and wheels, engine blocks and vehicle batteries. The main decline is partly blocked: a mound of mine waste covers most of the presumed opening and the rest is overgrown with vegetation. The interior of the decline can be seen through the vegetation and it appears that tyres have been dumped into the opening. The return airway entrance, near the office building, is underneath an open but overgrown concrete housing.

Most mine features remaining on the Gorteen site represent a hazard to some degree. The gantry is derelict and its upper levels are still accessible. The settling tanks have an unknown depth of water in them. The water is contaminated by coal dust and by dumped material, including electrical goods. The waste heap carries a risk of spontaneous combustion and its sides are unvegetated and potentially unstable. The old mine offices are roofless and the walls are unsupported and in danger of collapse.

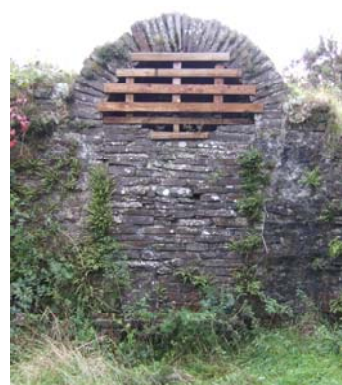
The old colliery site (1 ha) is now part of a private house and garden property. The old mine office building is now a private house and the main Foilacamin shaft (right) is located in the garden. The ventilation shaft, located close-by, is now filled in. The old chimney was removed before 1980 when the current owners bought the property. A thickly vegetated (gorse, etc.) waste heap covers the southern part of the site. The main shaft has an arched stone surround and a winch was set across the opening on top, resting on sleepers. The top has now been capped and the front blocked up (right).

A wooden lattice covers the only open part beneath the arch. Water was pumped out of this shaft by Ballingarry Collieries Ltd. in the 1960s and 70s, and later by Kealy Mines Ltd. in the 1980s, with the aim of lowering the volume of water in the workings at Gorteen.

In summary, the Foilacamin colliery site has been made safe through capping and blocking up of the main shaft housing. The opencast site, however, presents some significant hazards. The open pit itself is the most significant potential hazard to humans and livestock. There is only low barbed wire fencing at the top of the steep north wall although thick gorse provides additional protection around the edge. The depth of the lake is unknown. In addition, the action of rainwater of the solid waste is generating acid rock drainage (ARD). Periods of high rainfall can be expected to add significant quantities of such ARD to the open pit lake. Analyses suggest that the lake water has slightly reduced pH and raised concentrations of Cu, Ni, Zn and SO₄ compared to background concentrations for the district.

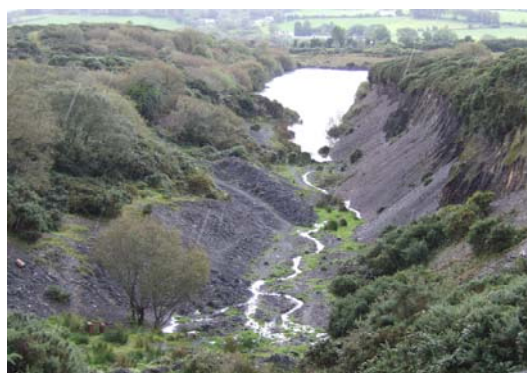
The excavations here are nevertheless very extensive. The open pit is flooded and drains via an overflow channel to the southwest. It is fed by a drainage channel from the northeast that carries surface water from the surrounding farmland (photo right, viewpoint toward southwest). The northern wall of the pit (hanging wall) is almost vertical but the ground to the south is benched and contains significant volumes of waste. Much of the site has undergone natural revegetation by gorse and other native species. The waste heaps are in use as cattle pasture although grass cover is poor.

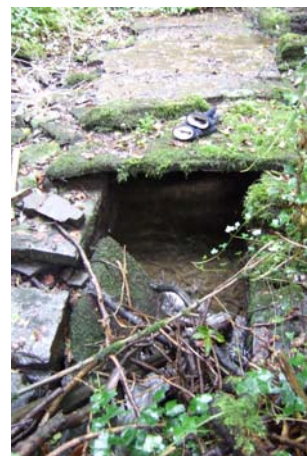
Southwest of the open pit Tobin's adit (photo, above) into the local stream. Tobin's adit appears to have been a 19th century adit that drained the old underground

workings immediately north of the open pit. The Cu concentration (44 µg/l) recorded at the adit in summer 2007 was slightly above that for background (upstream) surface water in the district (see Geochemistry section, below).

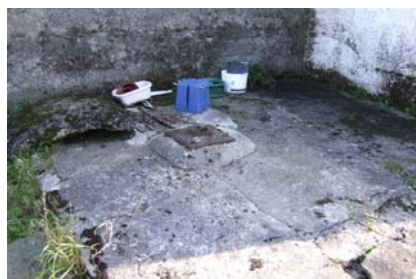
to underground workings, is now covered by a silage yard and cow shed (photo, above left). A small waste heap of shale remains beside the site of a third shaft but the shaft itself is not visible.

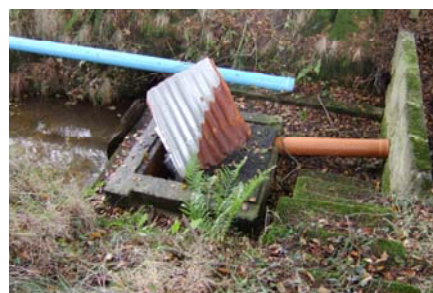
Almost 1km to the north, on higher ground, Gloune adit discharges a large volume of mine water (> 28 l/s in March 2007) (photo, right) from the shallow workings to the northeast.

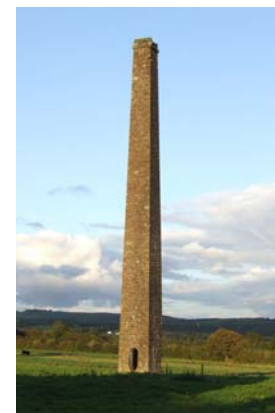
On the western edge of the site stands Copper Chimney (right), one of the finest 19th century (1863) mine buildings remaining in Slieve Ardagh. It is a 30m-high, quadrangular stack with an arched opening at the base. The chimney was apparently intended for ventilation of the level below: a fire built in the base of the chimney would create an updraft to draw air from the underground workings. However, the chimney was never connected to the underground workings (www.ballingarry.net). Loose stonework is apparent above the flange at the top and cracks are visible in the walls. The chimney has no lightning conductor.

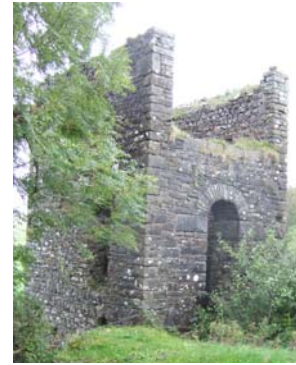
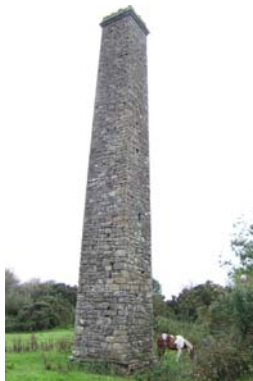
This site is 1km south of Coalbrook village, immediately west of the road. It is also known as Lisnamrock. The site contains two overgrown and plugged shafts and the remains of several mine buildings. The buildings include a substantially intact engine house (photo, above) and an 18m-high quadrangular chimney (photo, left). The small, occupied cottage at the roadside is apparently rebuilt or renovated from the original mine offices. The information about underground workings comes largely from an 1894 plan which shows a drainage adit running south from the workings to meet the local stream (Fig. 10). The status of this adit is unknown.

The engine house was built from large flat well-hewn stones with massive cubic corner stones and is generally sound. However, cracks are visible in the walls, lintels are missing and there are numerous loose or missing blocks, particularly along the

top. There is no lightening conductor. The chimney is similar in shape to that at Copper but lacks the arched opening at the base. Loose bricks are visible on the walls and it also lacks a lightening conductor. Nevertheless, it appears stable.

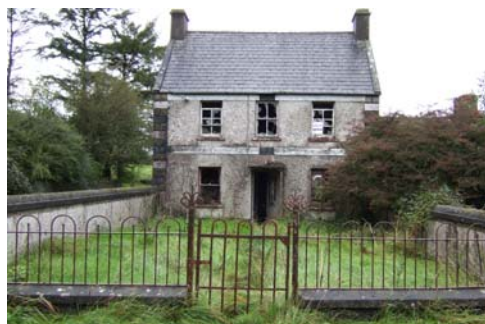
Along the entrance road to the west the old mine manager's house (photo, left) and offices are abandoned but still standing and in reasonable condition. To the rear of the house, in what is now a farm yard, a round building with pitched conical roof is a powder house or magazine (photo, top). The roof is intact and the building dry. The door lintel is broken and requires repair.

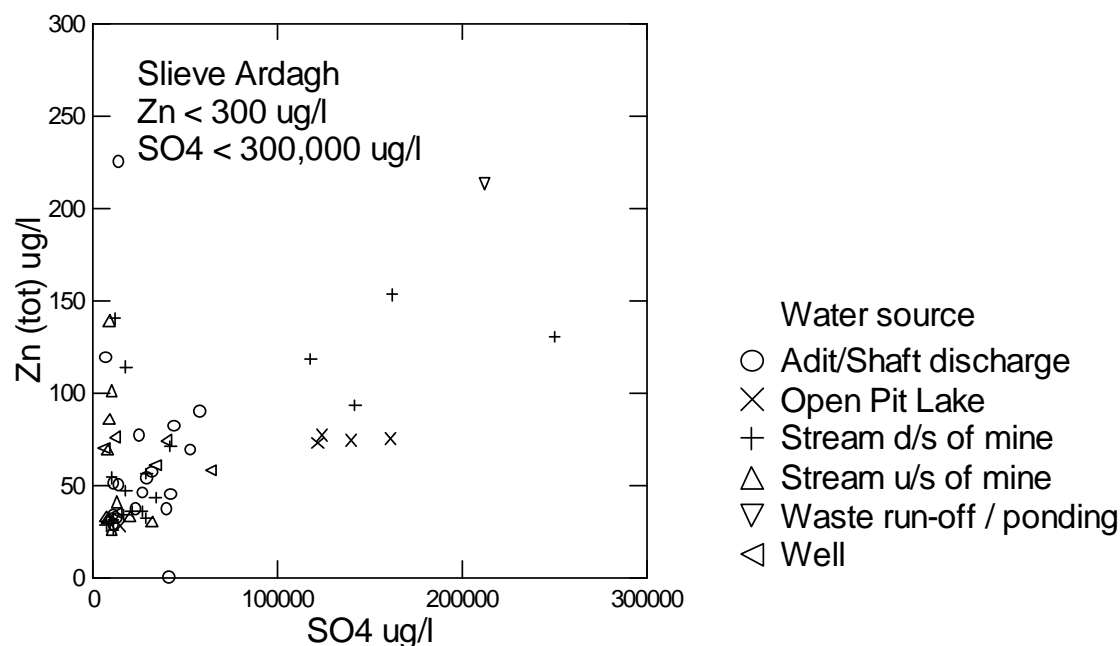
Fig. 14 Zn v SO_4 by water source, Slieve Ardagh

Fig. 14 shows a partial plot of Zn (tot) v SO₄ where values of Zn > 300 µg/l and SO₄ > 300,000 µg/l, i.e. samples from Foilacamin run-off only, are excluded. Most water samples have Zn < 150 µg/l and SO₄ < 70,000 µg/l and cannot readily be separated on the basis of these chemical parameters. The exceptions, apart from the run-off samples, are four downstream samples and four open pit lake samples. The downstream samples are all from two sites in Gorteen, taken in both winter and summer, and the open pit lake samples are all from Foilacamin, again taken in both winter and summer. In both cases, this suggests that the waste at Gorteen and

Foillacamin is influencing the composition of the surface water at the sites. The corollary is that elsewhere in the Slieve Ardagh district surface water does not appear to show any significant impact from mining. Of particular interest are the relatively low concentrations of metals and SO_4 observed in adit discharges (Fig. 14 and Table 2). By analogy with the run-off samples, where direct contact between the water and coal waste can be observed, it appears that water draining the underground mine workings via adits may not be equilibrating chemically with coal and the sulphide minerals it contains.

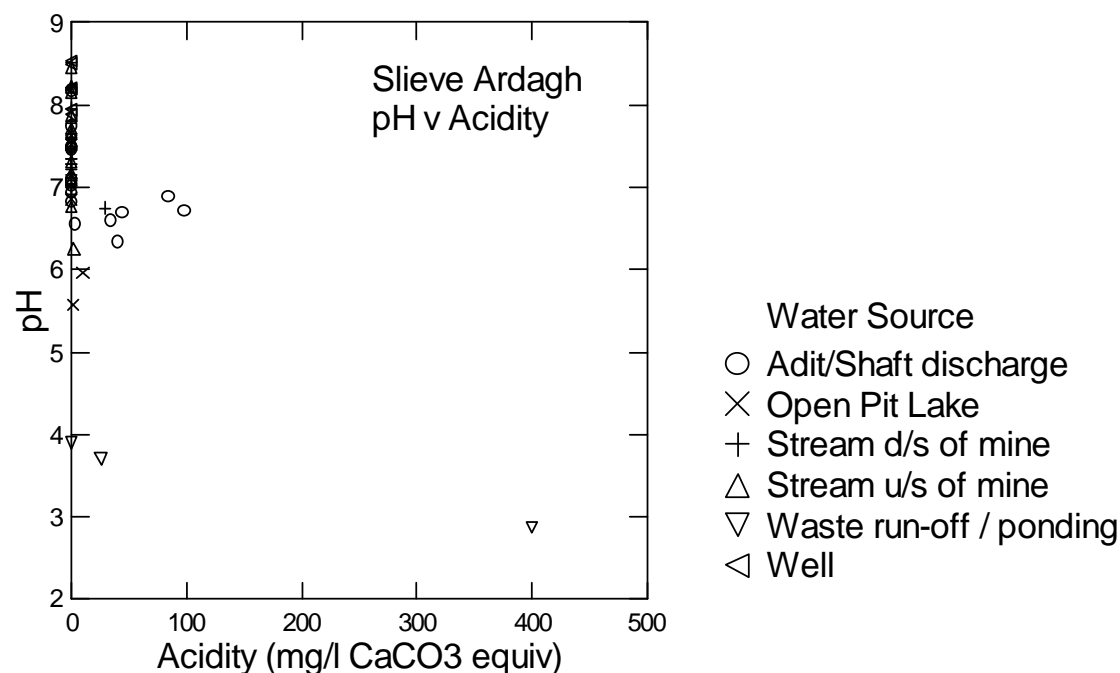
Fig. 15 pH v Acidity, Slieve Ardagh

Apart from metal contamination, the most important chemical issue related to mine water discharges from coal mines worldwide is acid mine drainage (AMD) or acid rock drainage (ARD), generated as a consequence of reaction between mine water and sulphides, mainly pyrite, in the coal and its host rock. Although some run-off samples at Slieve Ardagh had low pH, only one, taken in summer at Foilacamin, had acidity in excess of 100 mg/l CaCO₃ equivalent (Fig. 15). Most water samples taken at Slieve Ardagh had pH > 7 and alkalinity was measured instead but for those with pH < 7 the measured acidity is generally low. This reflects the general absence of significant concentrations of ions, e.g. metals, in the water. In consequence, although low-pH, high-acidity samples can be generated under specific circumstances and in specific locations, acidity is generally not a significant factor at Slieve Ardagh and the risk of AMD therefore appears to be low.

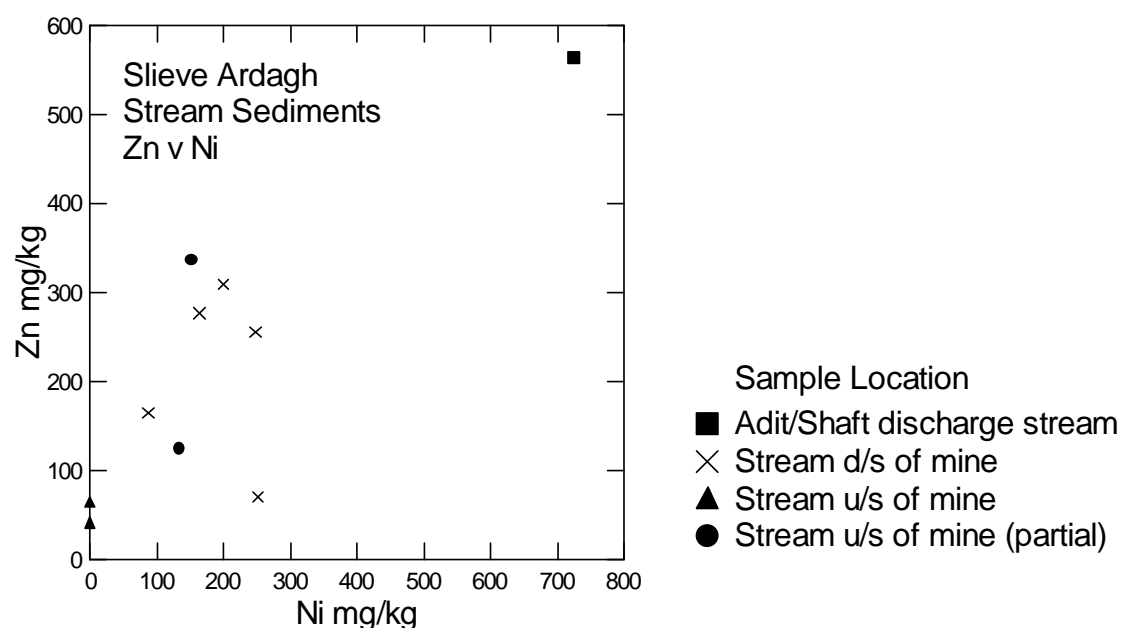
Fig. 17 Zn v Ni, Stream sediments, Slieve Ardagh

The total number of samples collected (10) is low but it is nevertheless possible to discern some patterns in the data. Some elements, e.g. Sb, Cd, Cr, V, were below the detection limit in all or most samples whereas As, Zn, Cu, Ni, and Mn are present in concentrations well above those found in the two truly upstream samples. The concentrations of the elements in downstream samples and the adit discharge stream indicate that the elevated concentrations measured can be directly attributed to coal mining. This is well illustrated by Fig. 17.

The presence of Ni in stream sediments and the failure to detect it in solid waste analyses is of interest. The fine fraction (< 150 µm) collected tends to concentrate metals and this may be sufficient to account for the observed data. Certainly, Ni seems to be present in coal mine waste but at levels too low to be detected and measured using the techniques employed in this study.

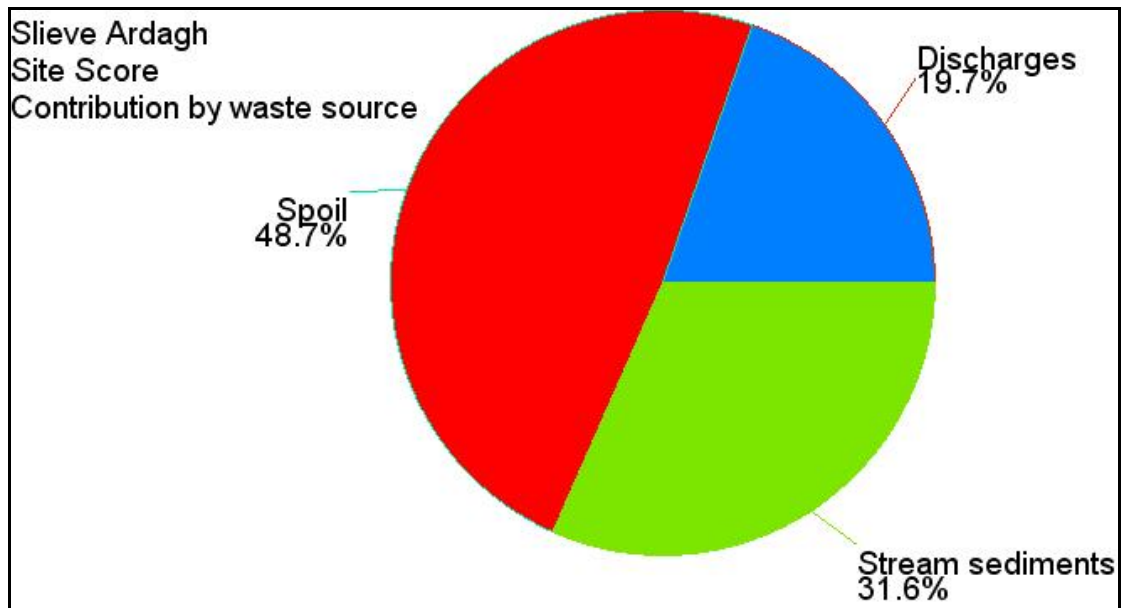
Fig. 19 Slieve Ardagh district, site scores, contribution by waste source

Table 6 gives the HMS-IRC site scores for each individual waste source in Slieve Ardagh that has been scored. The total score for the district is 117, placing the district in HMS-IRC Class IV. Of this score of 117, solid waste accounts for almost 50% (57), stream sediments 32% (37) and adit discharges 20% (23) (Fig. 19). Solid waste was analysed only at two sites, Gorteen and Foilacamin, but the median concentrations of the analyses for these two sites were applied to all other waste heaps in order to generate site scores. The high proportion of the total site score contributed by solid waste (total score = 57) reflects (1) the large number of waste heaps recorded in the district, most contributing very low scores (1 – 2), as well as the contribution of two very large heaps at Gorteen (score = 13) and Foilacamin (19) and (2) the generally low scores of the mine adit discharges. The latter do not generally contain high concentrations of metals so, despite the large volumes of water discharged by some of them, notably at Ballynnty (score = 6) and Gloune (4), they make only limited contributions to the total score.

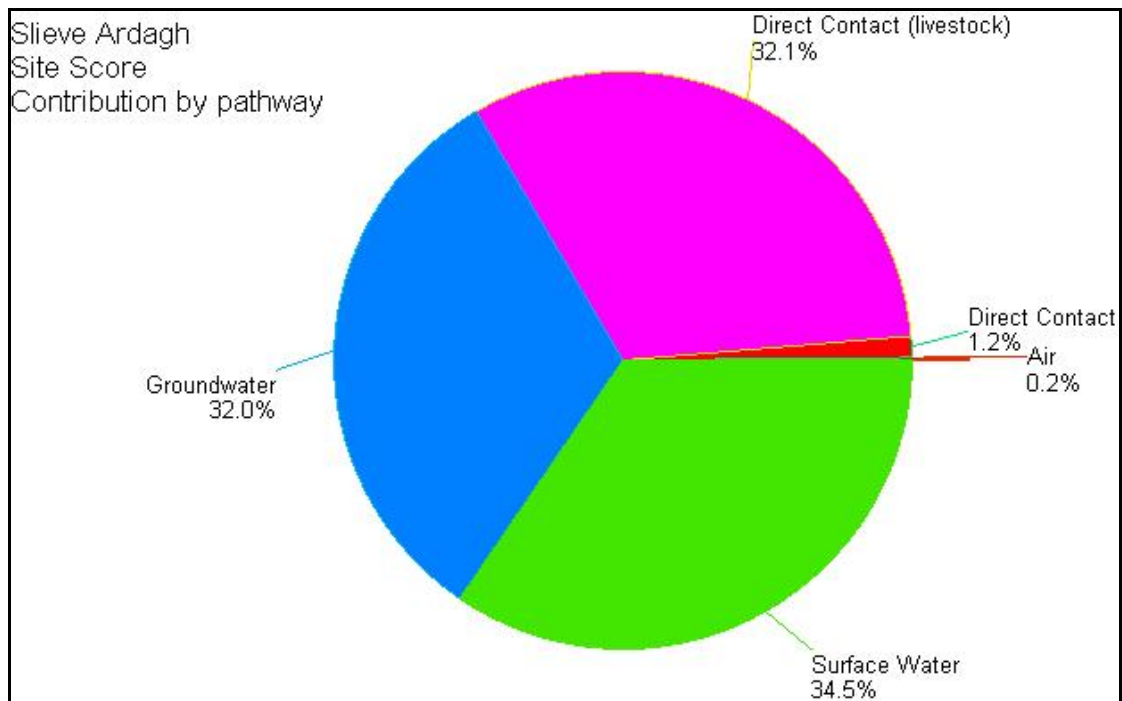
Fig. 20 Slieve Ardagh district, site scores, contribution by pathway

Fig. 20 shows the contribution to the total site score by individual pathways. The proximity of streams to most sites boosts the surface pathway score but this is balanced by the groundwater vulnerability ("extreme" aquifer vulnerability in most cases, according to GSI's classification). The relatively large contribution by stream sediments reflects the extensive drainage network in the area, the fact that three streams are scored and the low absolute scores contributed by solid waste and water discharges.
