GLANDORE

Mine Name: Glandore

Project Prefix: AGH-

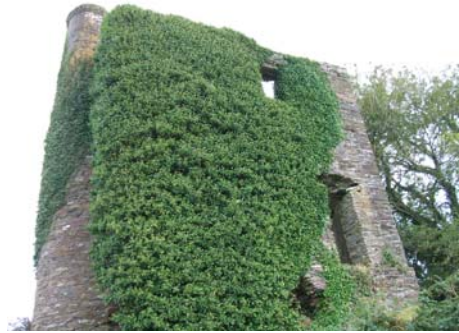
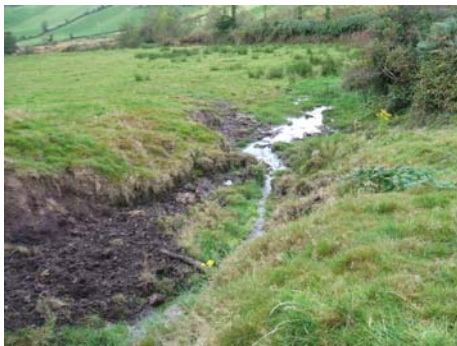
The site itself is centred on the shell of the engine house and the large open pit beside and to the south of it. A private house is located immediately to the east of the engine house. The engine house is an impressive structure, with an intact chimney. Its bob wall faces the open pit; a poorly fenced, collapsed shaft close to it is presumably the engine shaft. No trace was found of several other shafts marked on old plans - Reilly (1986) shows the approximate locations of as many as six shafts. The most significant of these was the Copper Shaft, sunk in 1869 after discovery of the copper lode. It was located east of the open pit and intersected the deep adit 36m below the surface (Reilly 1986). Along with the other shafts that lay outside the area of the open pit, it has been filled in. The open pit itself is made inaccessible by thick, impenetrable overgrowth.

The mine is drained by the deep adit, which runs along a line from the Copper Shaft to the open pit and thence northwest (Fig. 1). Its mouth is close to the small stream that runs through the floor of the valley at the base of the hill on which the mine site is situated. The adit has now partly collapsed and its mouth is obscured by brambles and vegetation. A small flow of mine water discharges from the adit (photo, left).
