BALLYHICKEY

Mine District: Clare Lead Mines

Mine Name: Ballyhickey

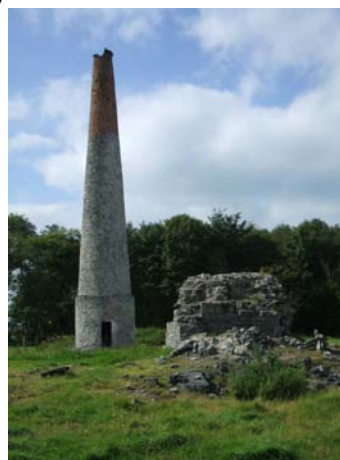
According to Cowman (1992) the mineralization was discovered by Taylor in 1834 who was seeking an extension of the lode at Kilbricken, 2 km to the southeast. Between 1834 and 1838 a steam engine and engine house (photo, right) was erected on site and 2500 tons of ore were extracted from an opencast. The opencast was 30m deep and 60m long (Cowman 1992). The ore was shipped from Clare port to Dee, via the river Fergus. Mining appears to have died out rapidly after 1838 and by 1840 production had declined to around 40 tons per month with the ore considered to have been nearly "worn out" (Cole 1922). However, there are records of minor production up to 1846 (Cole 1922). The works were reopened in 1853 and cleaned out but no ore was produced and these trials probably finished some time in 1854 (Cowman 1992).

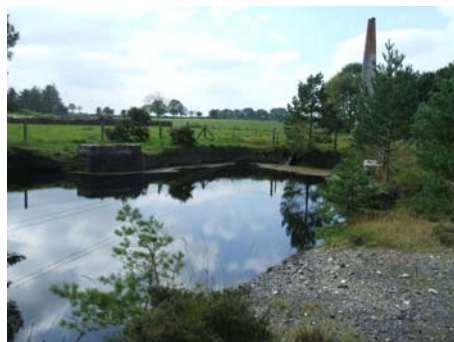
Most of the 2.5-ha Ballyhickey site (Fig. 1) is now grassed over and has been in use as a pasture field, although no evidence for recent use was observed during site visits for the HMS-IRC project. It is bordered on two sides by a commercial forest. The engine house chimney (photo, above) is largely intact although some bricks have fallen from the top. Part of one wall of the engine house is still standing. It is around 2m high and less than 4m long. The open pit is flooded to within 1 m of the surface and is securely fenced (photo, right). A rope from the old pulley system remains stretched across the width of the pit. Some coarse-grained mine waste lies around the base of the chimney and the remains of the engine house but most of the solid waste on the site is covered by soil and grass (SP01, Fig. 1). Removal of the grass and soil cover reveals coarse fragments of vein calcite. At the northwestern corner of SP01 a 1m-deep ditch has cut into fine-grained, grey-green tailings-like material. Table 1 provides an estimate of the area and volume of solid waste on the site, based on an assumed thickness of 0.5m.

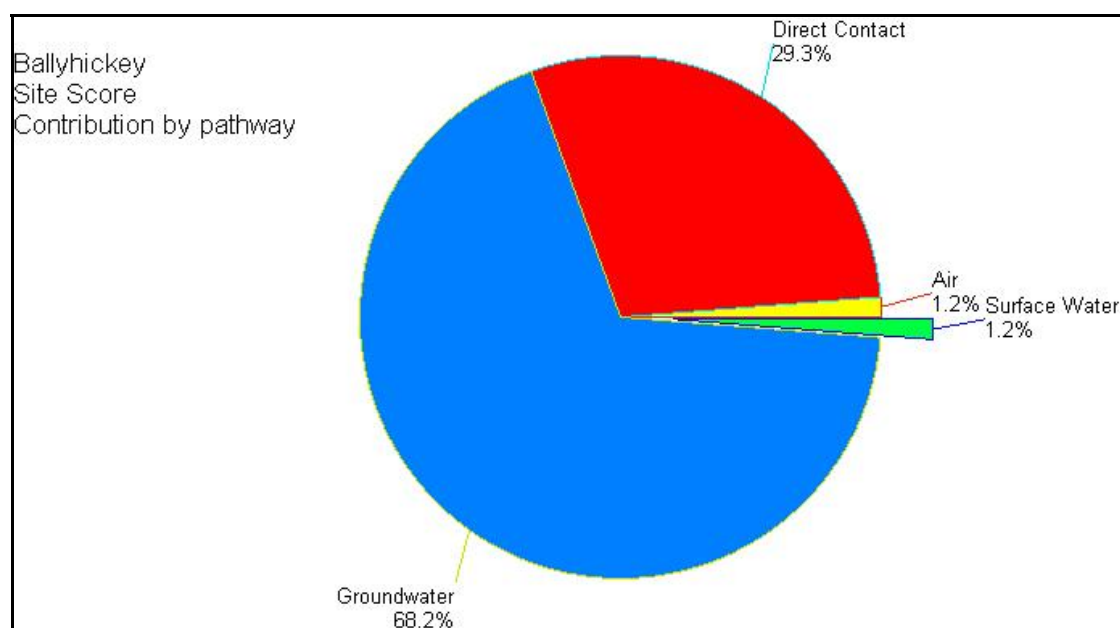
Fig. 3 HMS-IRC Site Score, Ballyhickey: contribution by pathway

The HMS-IRC Site Score for Ballyhickey is 19 (Class V), contributed wholly by SP01 (Table 3). The mortar analyses were excluded when calculating the median composition of solid waste for use in the scoring system. The very high concentrations of Pb recorded on the site would typically lead to a high site score but several factors limit the final score at Ballyhickey. The estimated volume of waste, calculated by assuming a thickness of 0.5m, in the absence of any thickness measurements, is not particularly high. The lack of any surface water courses reduces almost entirely the contribution of the surface water pathway and eliminates the potential for a direct contact (livestock), i.e. stream sediment, pathway score (Fig. 3).
