CROOKHAVEN

Mine Name: Crookhaven

Site Description and Environmental Setting

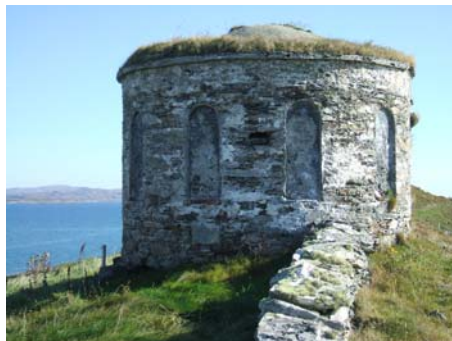
There are several mine buildings at Crookhaven in various states of preservation. Two distinctive powder houses, or magazines, are almost wholly intact, one on the northern side and the other to the southern side of the peninsula (photo, right). The former is fenced off and used as a hen house. Low walls and the base of a chimney are all that remain of the engine house (photo, below left). The site of the old
